Glenwood Manor - Condominium Corporation No. 8110119

April 15, 2024

**Re: Reserve Fund Study for Condominium Corporation No. 8110119 - 904 & 908 Memorial Drive NW**

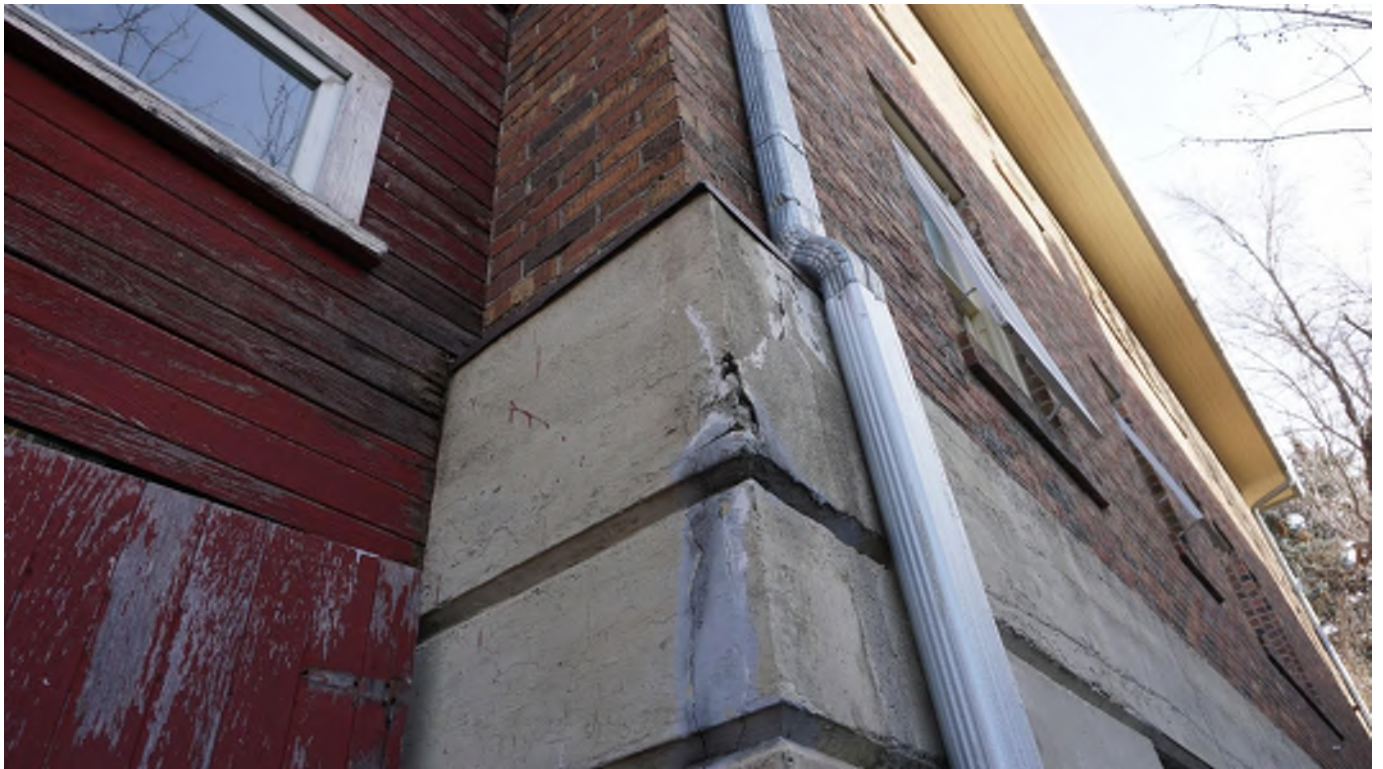
Figure 1 - Example of decorative features of the foundation wall and spawl damage due to previous downspout failure.

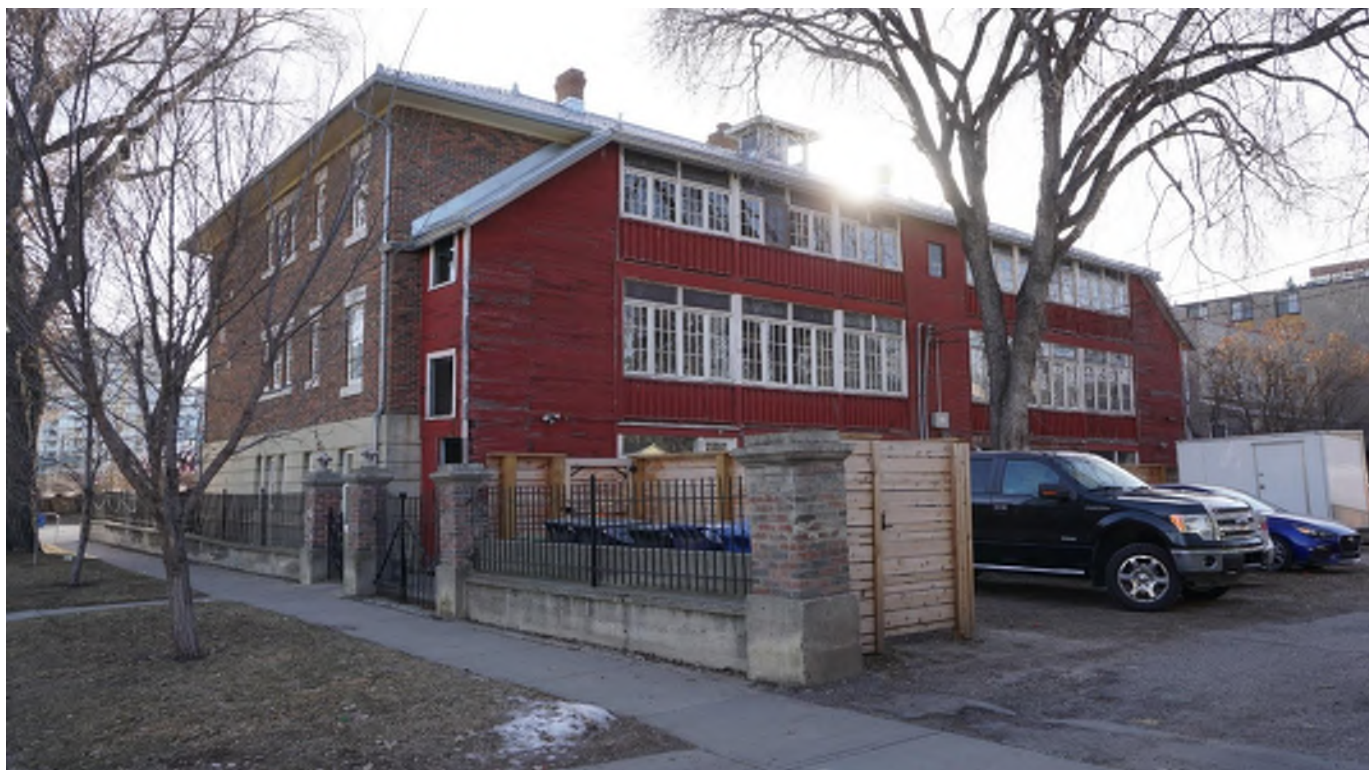
Figure 3 - View of the rear veranda.

#### 4.5.1.02 - SUBSTRUCTURE - REPAIR SETTLED PILES – REAR VERANDA

| Repair Settled Piles – Rear Veranda | | |
|---|---|---|
| | Expenditure Estimate | \$72,450 |

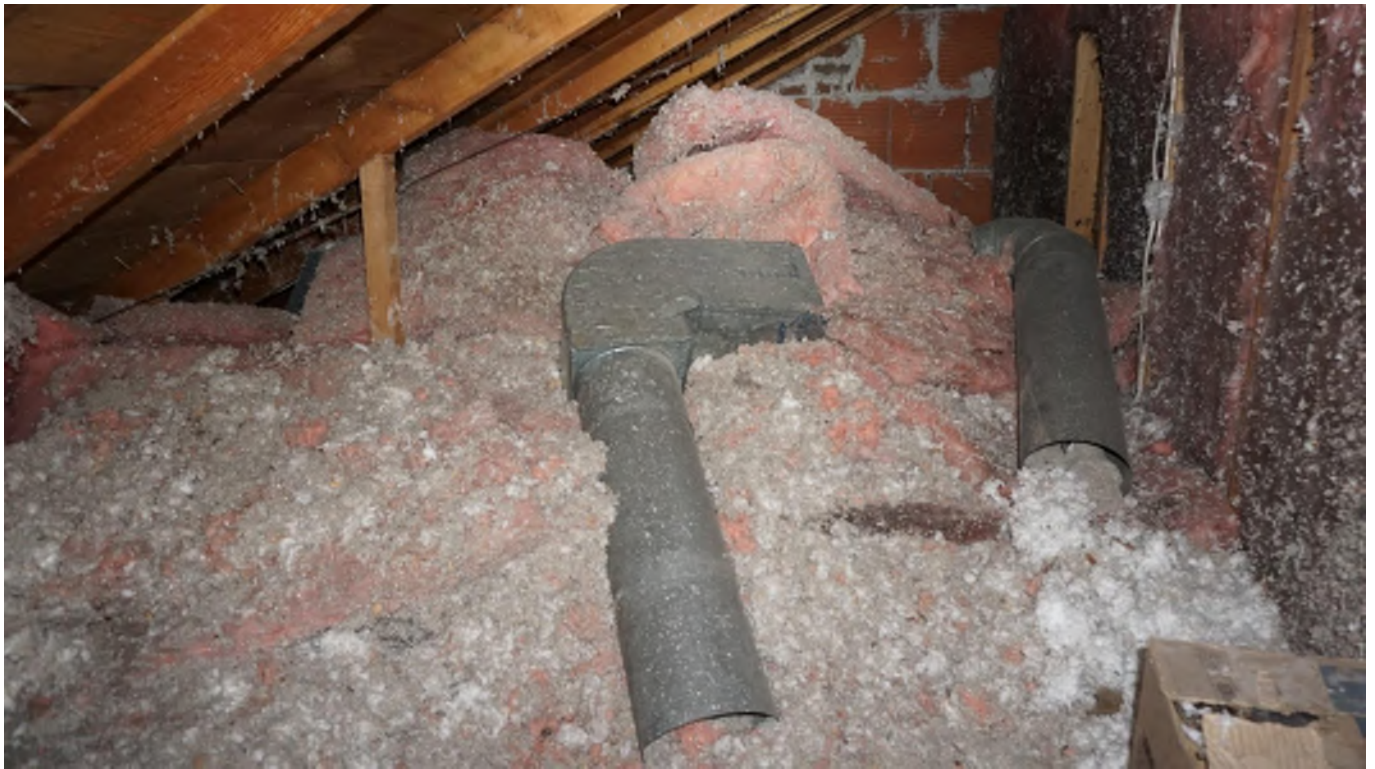
Figure 4 - Example of disturbed insulation and surplus ducting.

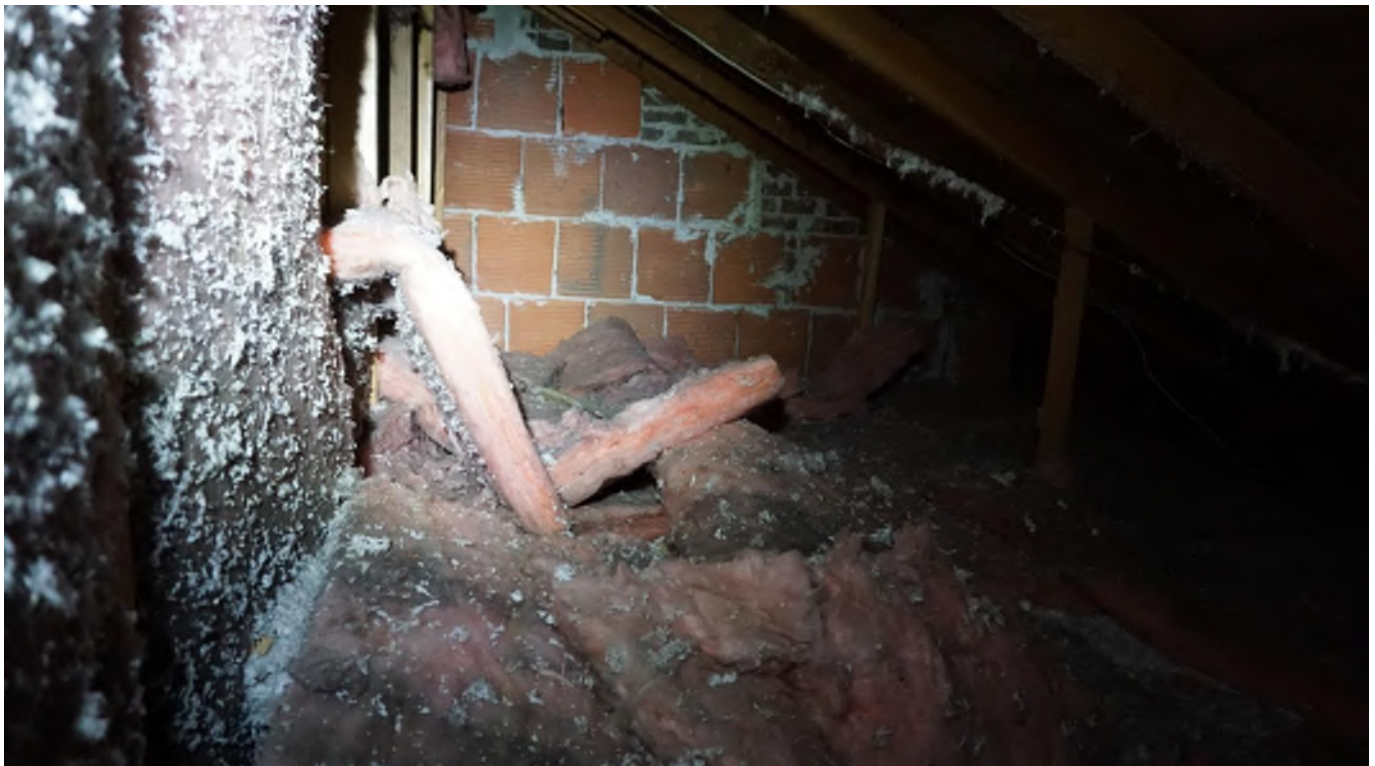
Figure 5 - Example of uninsulated knee-wall sections.

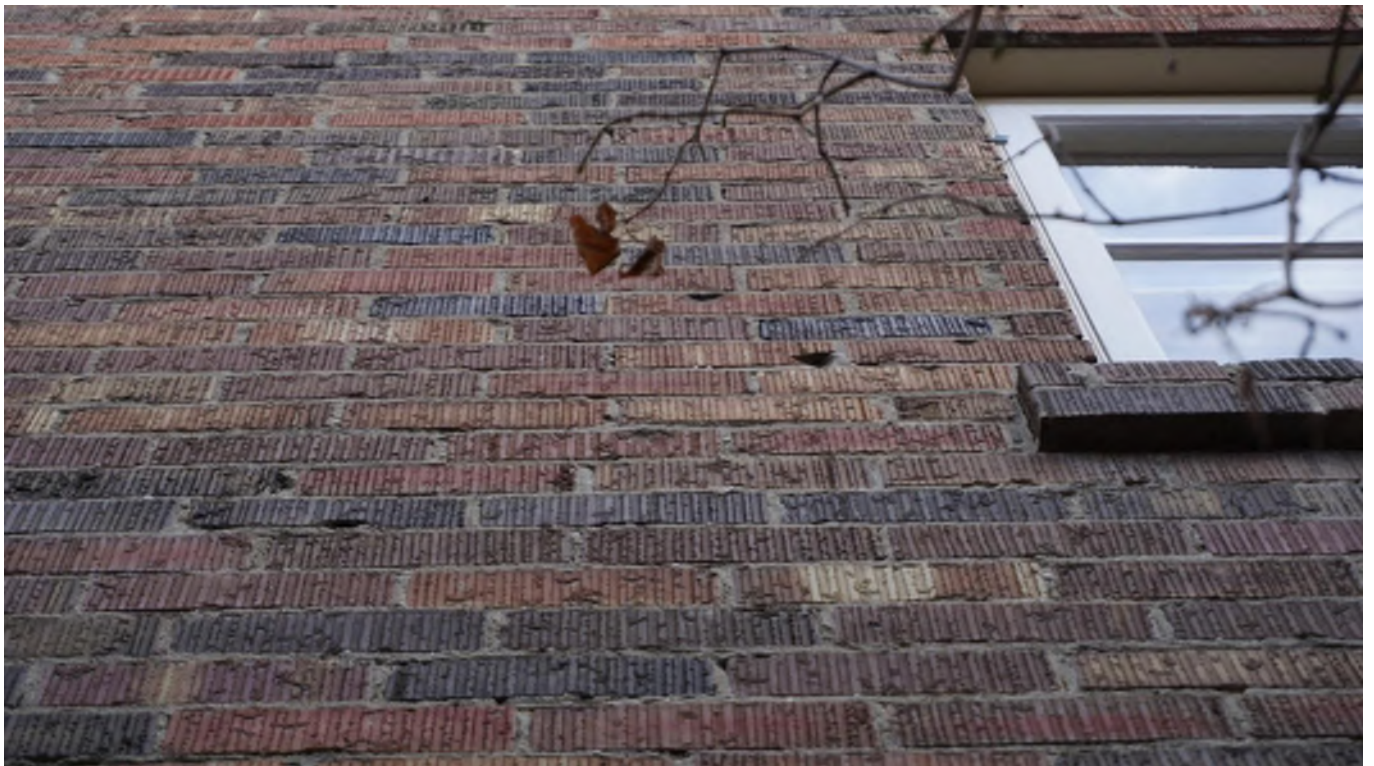
Figure 7 - Example of fluted style clay bricks showing some brick and mortar damage.

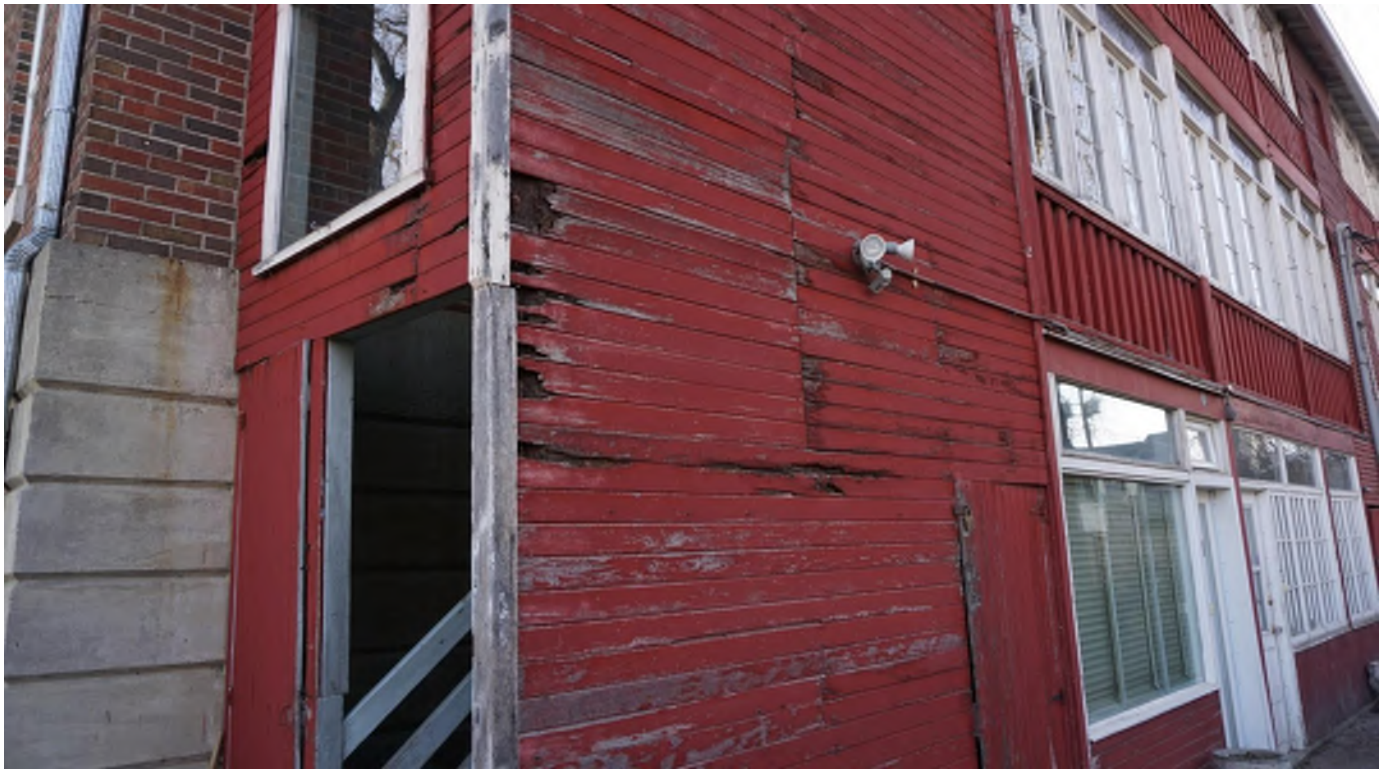
Figure 18 - Example of extensive deterioration of the wood siding.

#### 4.5.3.10 - EXTERIOR WALLS - VERANDA REHAB - SWDT

| Veranda Rehab - SWDT | | |
|---|---|---|
| | Expenditure Estimate | \$44,295 |

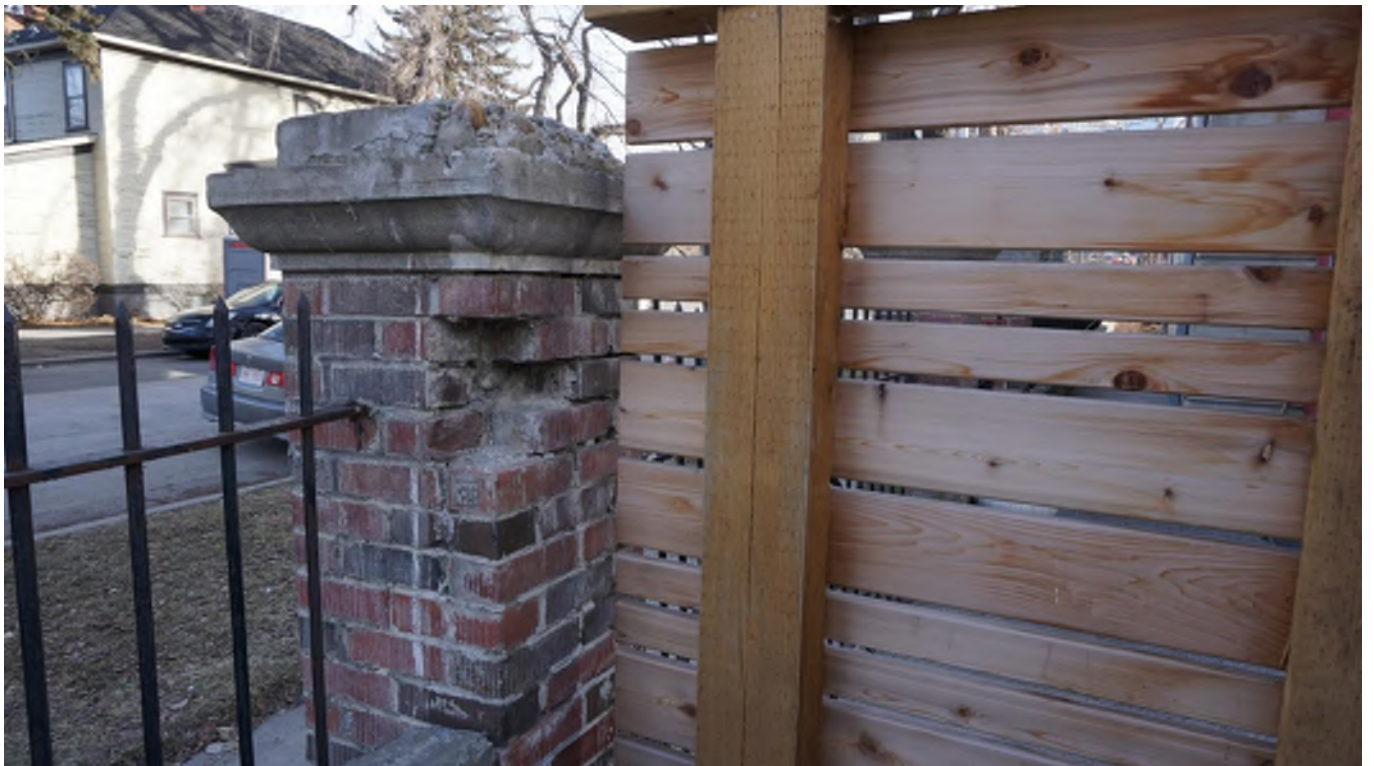
Figure 66 - Significant deterioration of a column at the northeast corner.

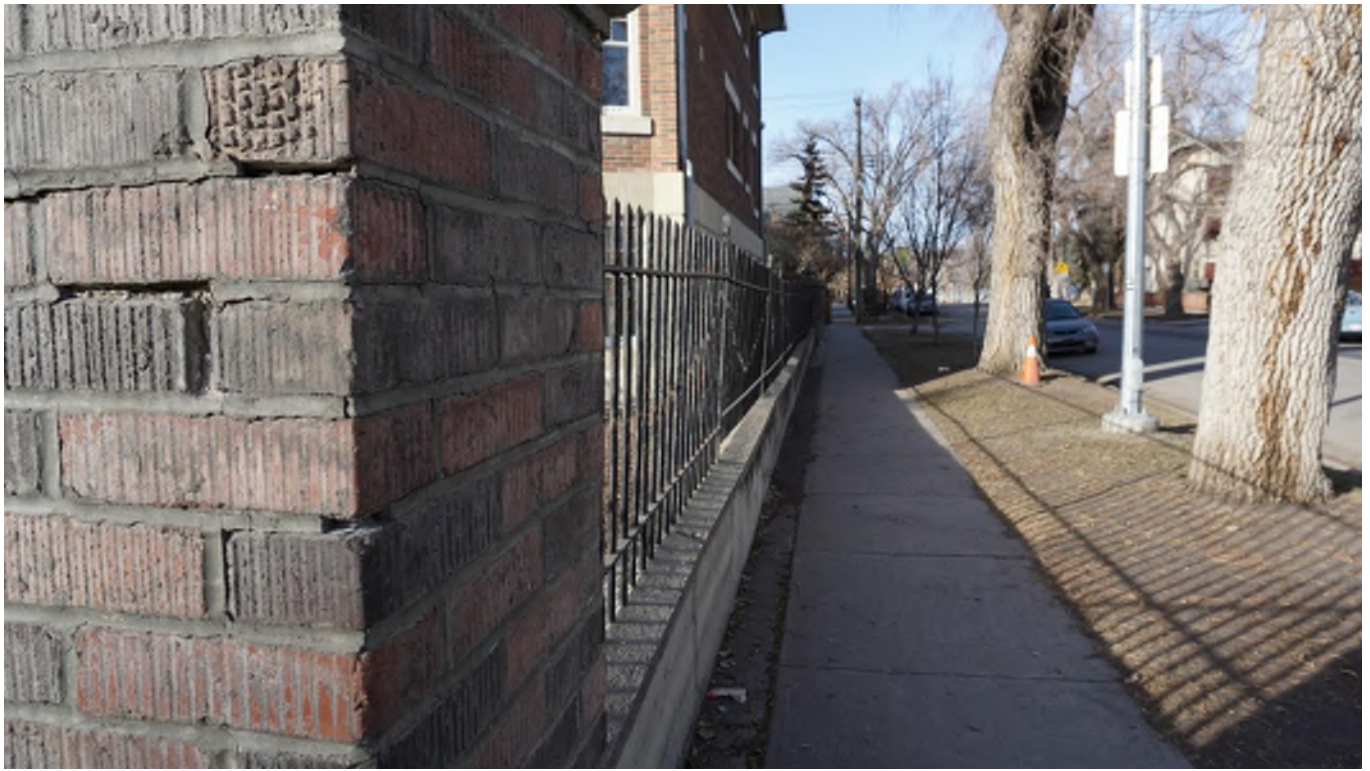
Figure 67 - Some leaning of the metal fence.

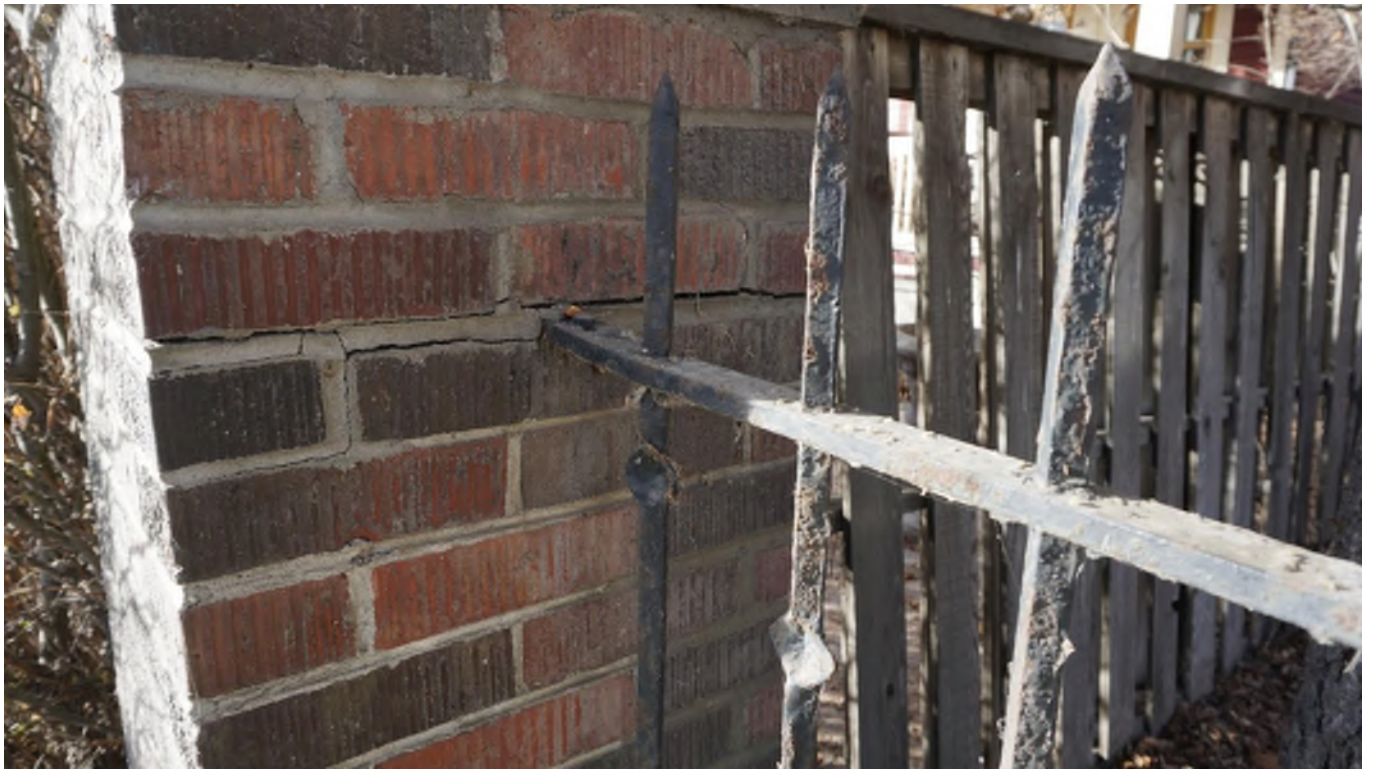
Figure 68 - Example of metal corrosion and mortar cracking typical on the fence.
