Glenwood Manor - Condominium Corporation No. 8110119

April 15, 2024

**Re: Reserve Fund Study for Condominium Corporation No. 8110119 - 904 & 908 Memorial Drive NW**

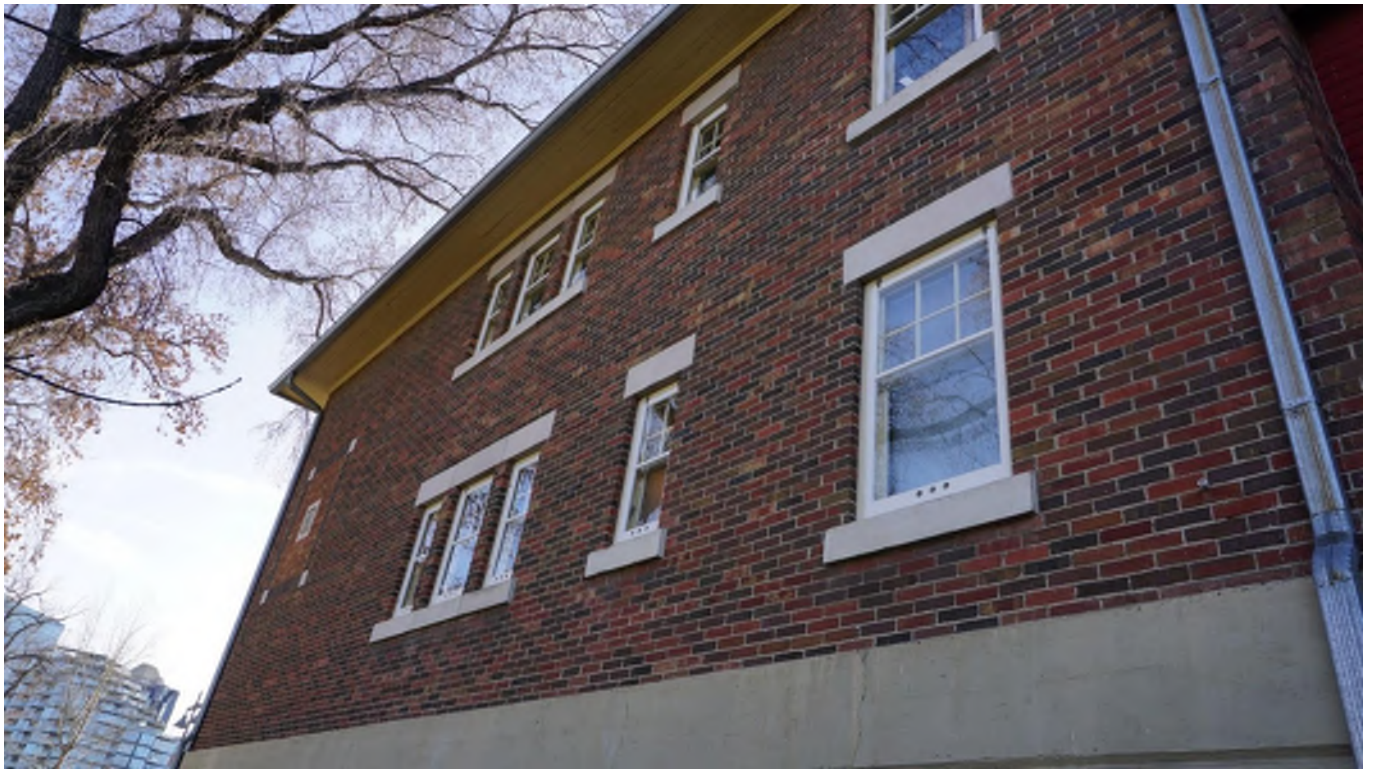
Figure 6 - Example of the general character of the brick facade.

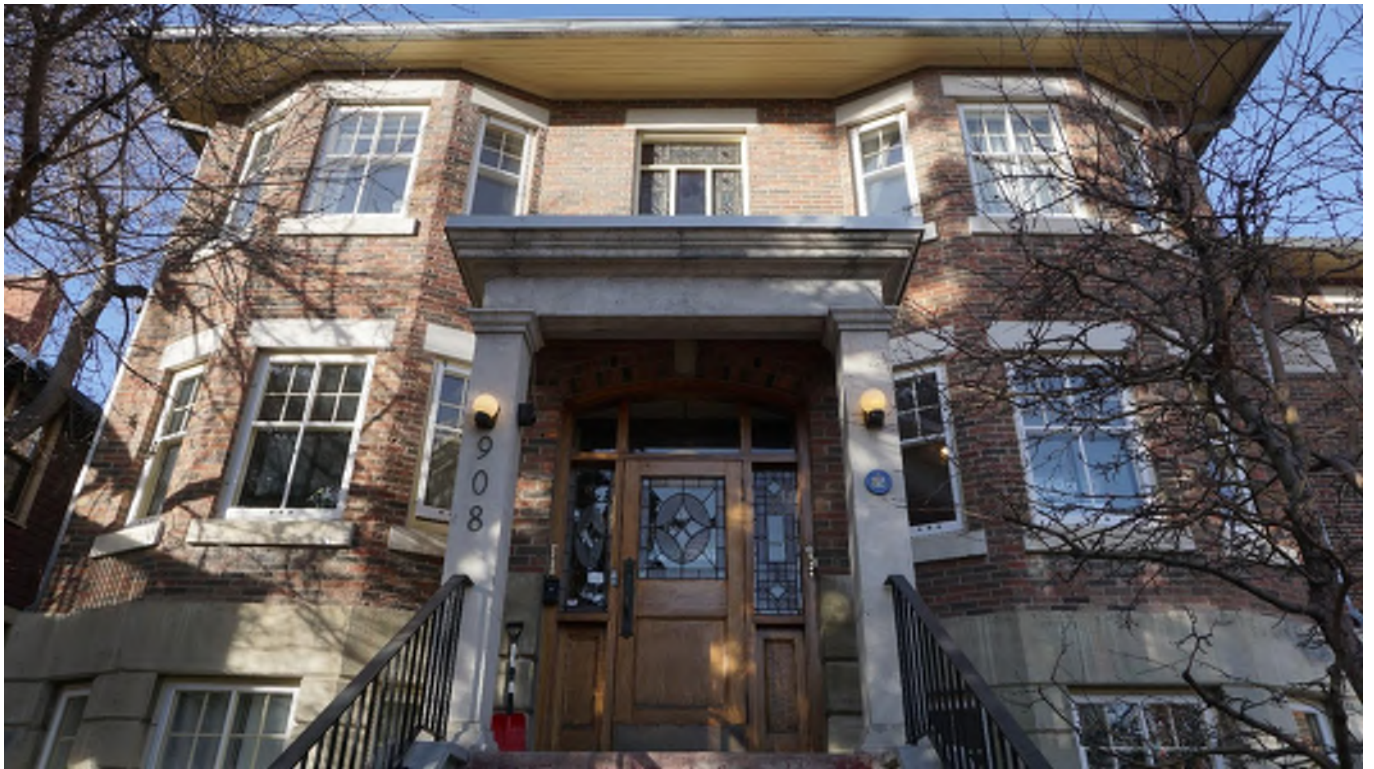
Figure 8 - Exterior view of the original hardwood doors with original hardware.

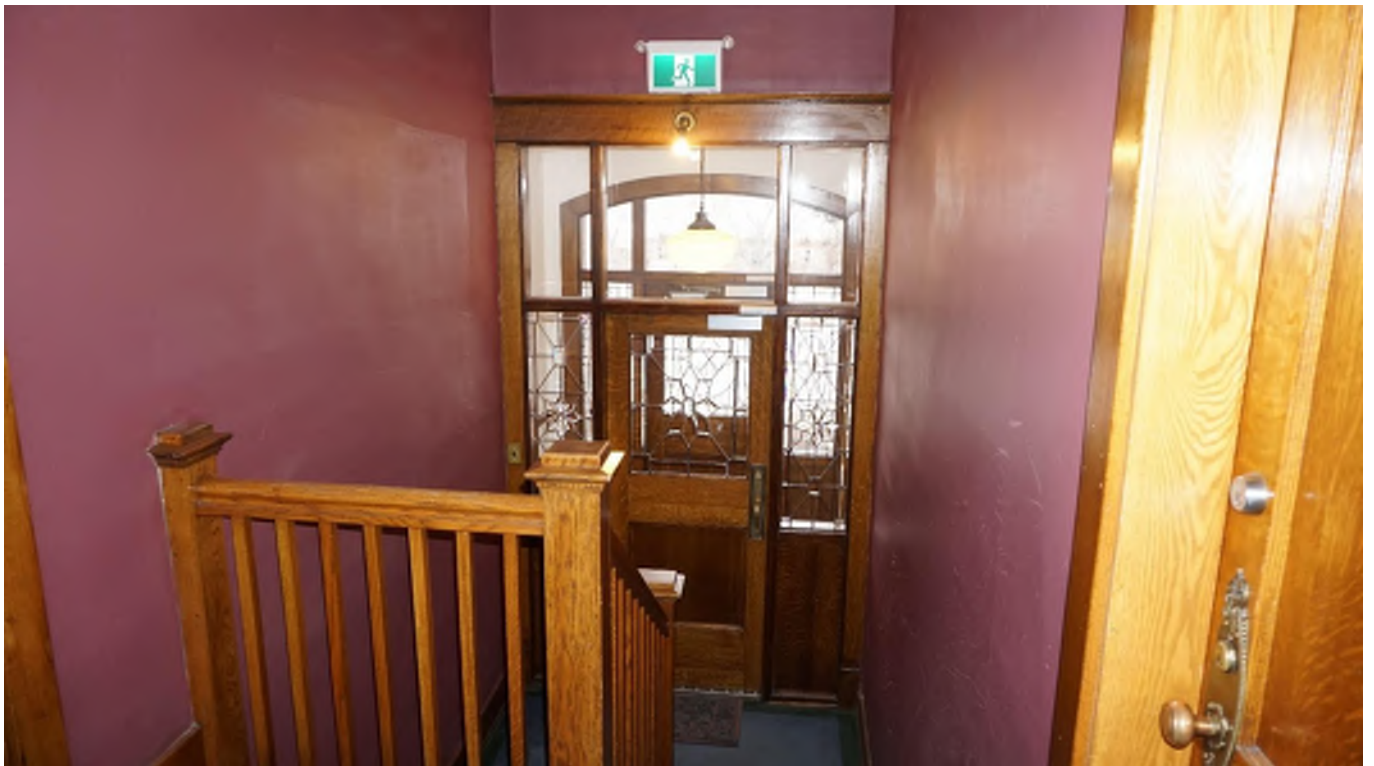
Figure 9 - View of the interior side of the entry door system.

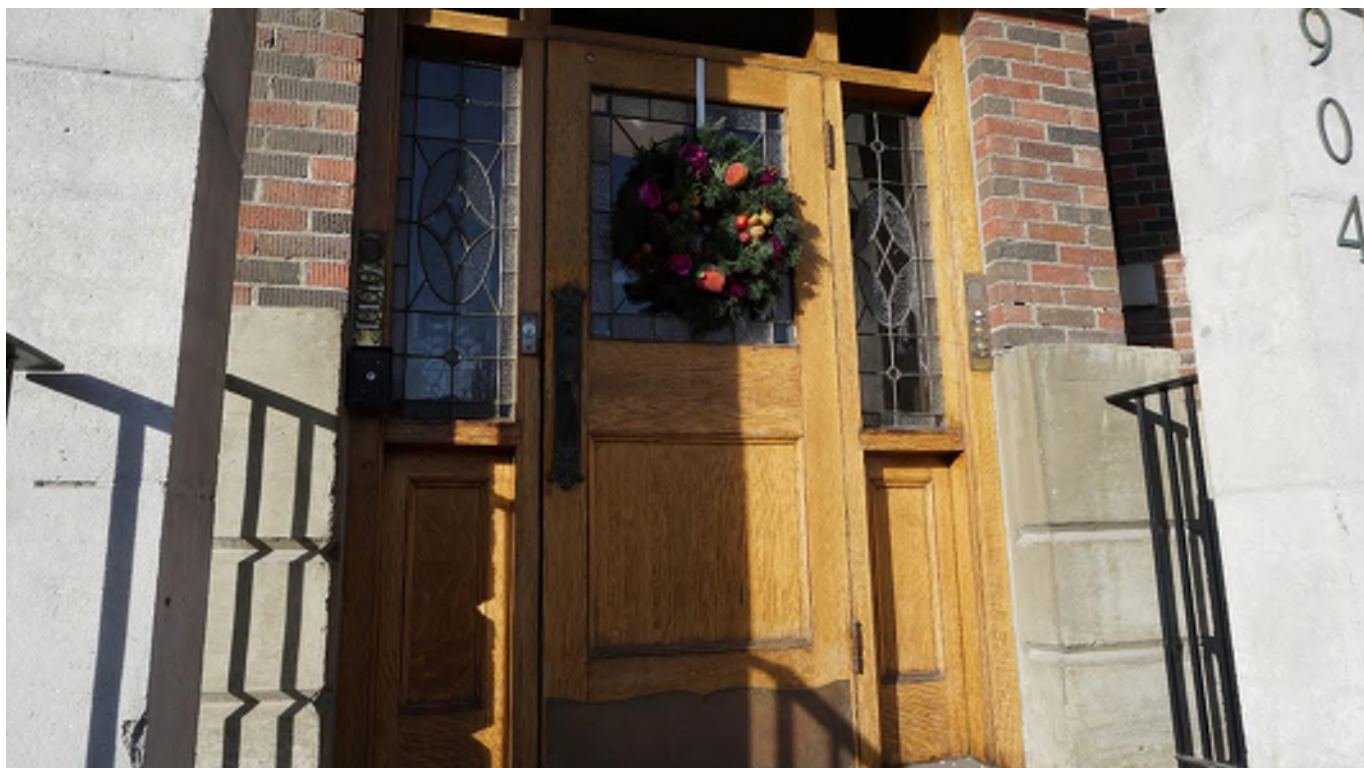
Figure 10 - Exterior view of the original hardwood doors with original hardware.

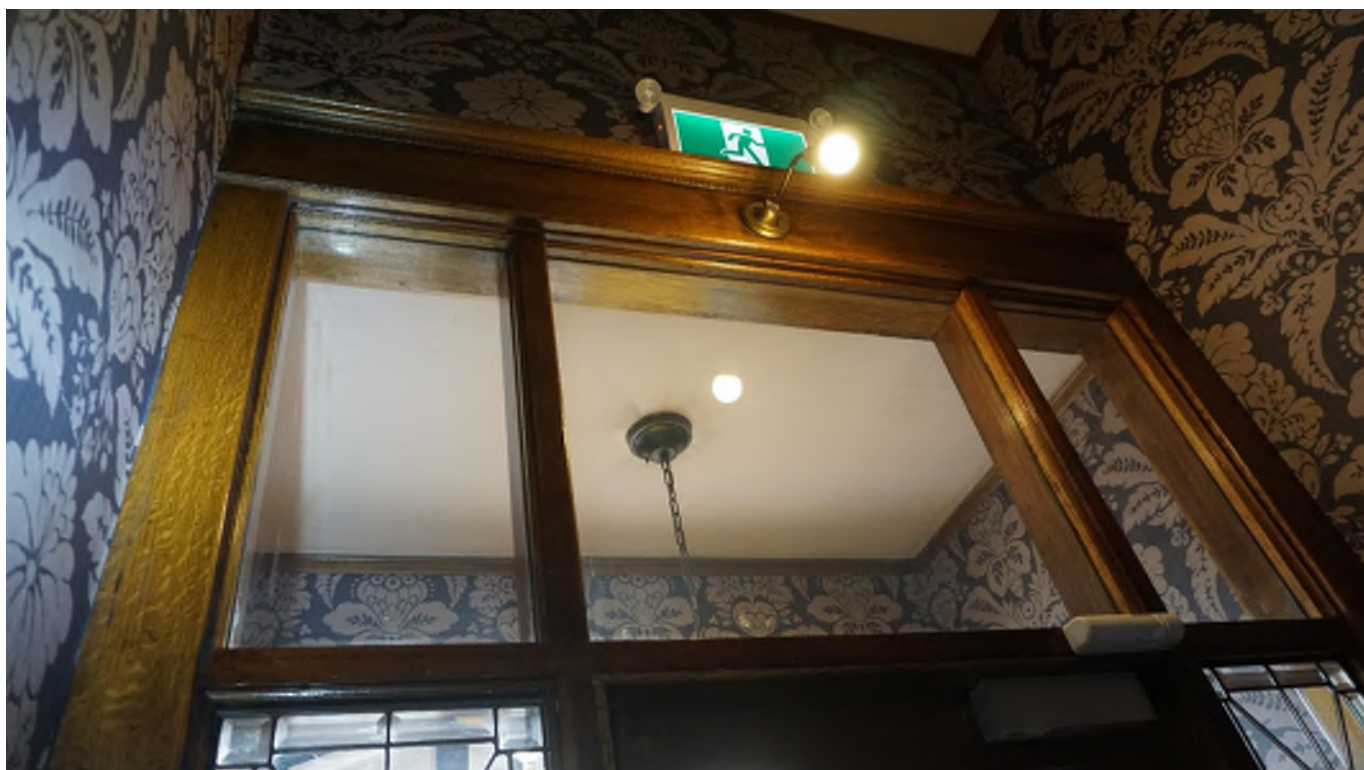
Figure 11 - View of woodwork detail of the inner vestibule.

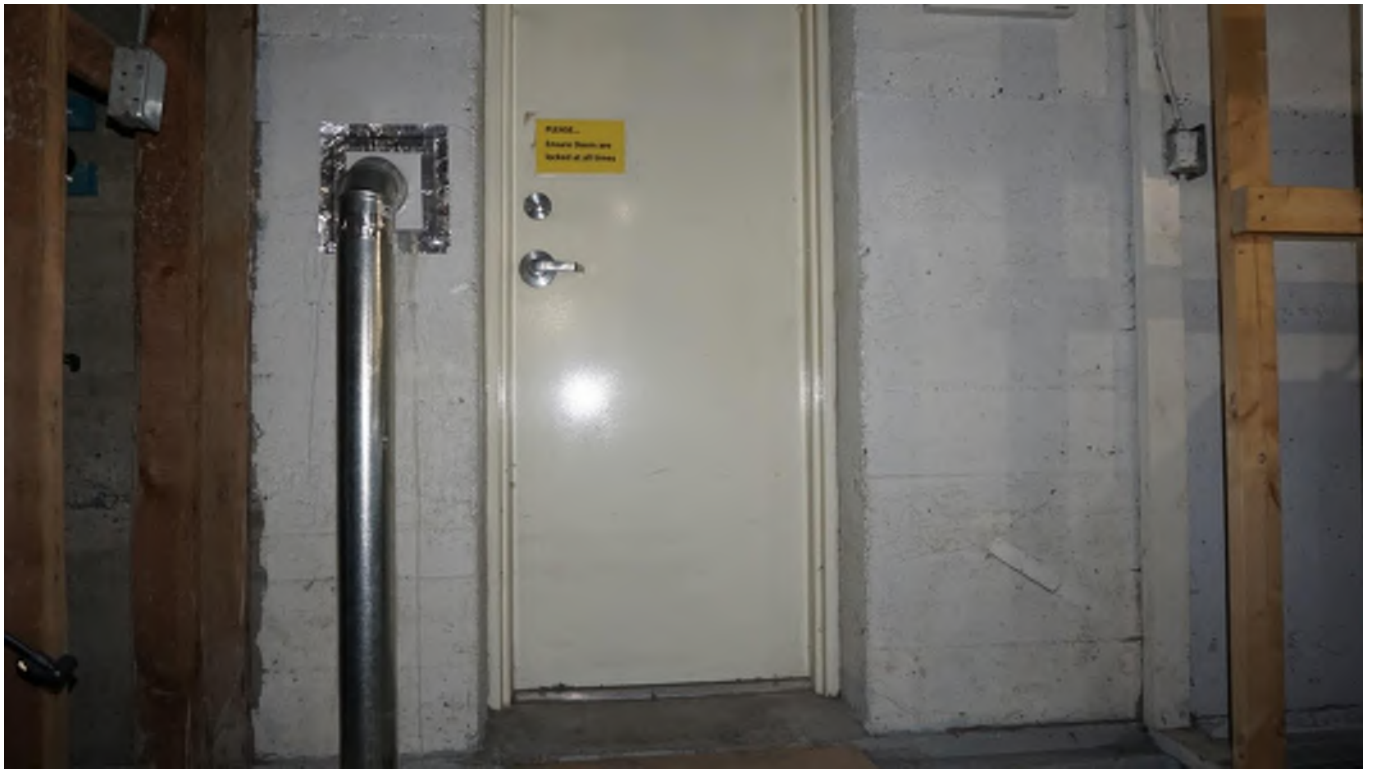
Figure 12 - Example of metal basement exit door.

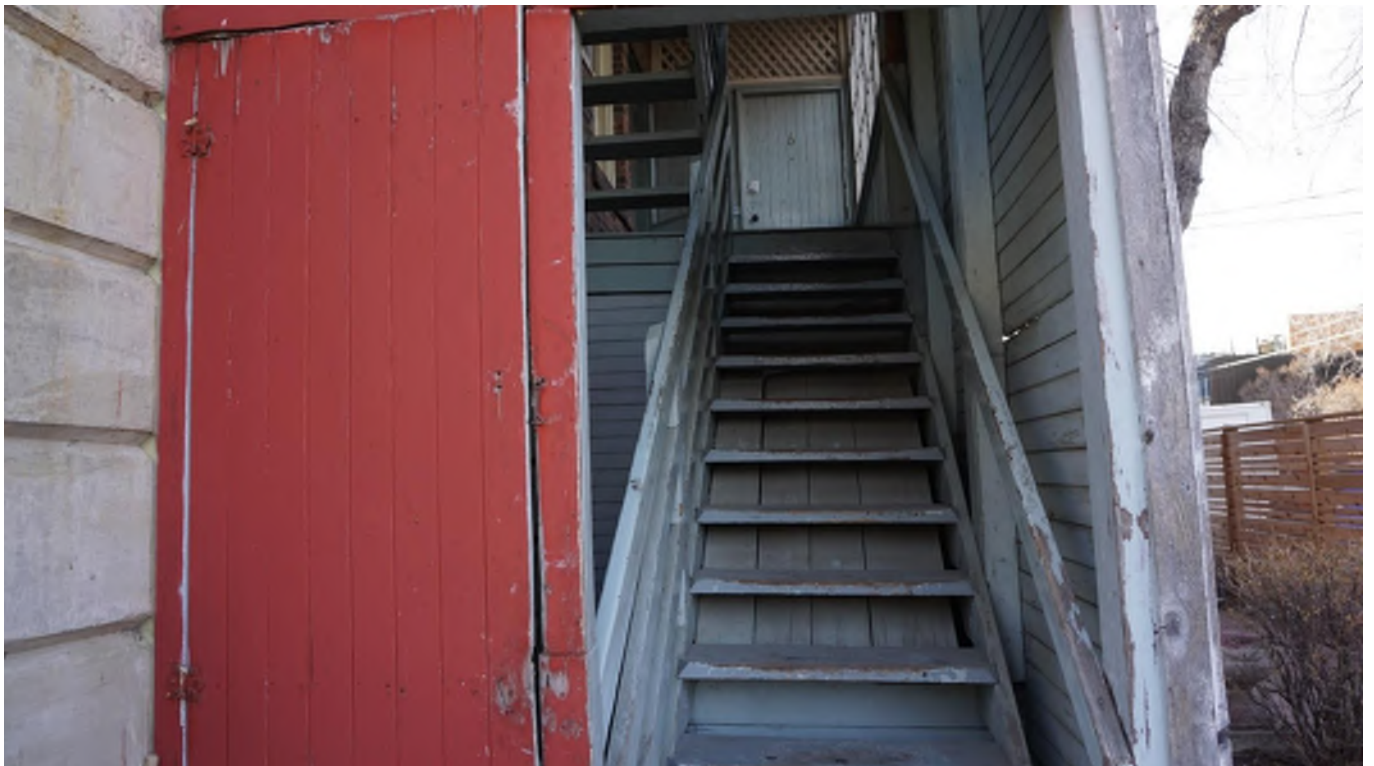
Figure 14 - Example of veranda partition door and safety door for external basement stairwell.

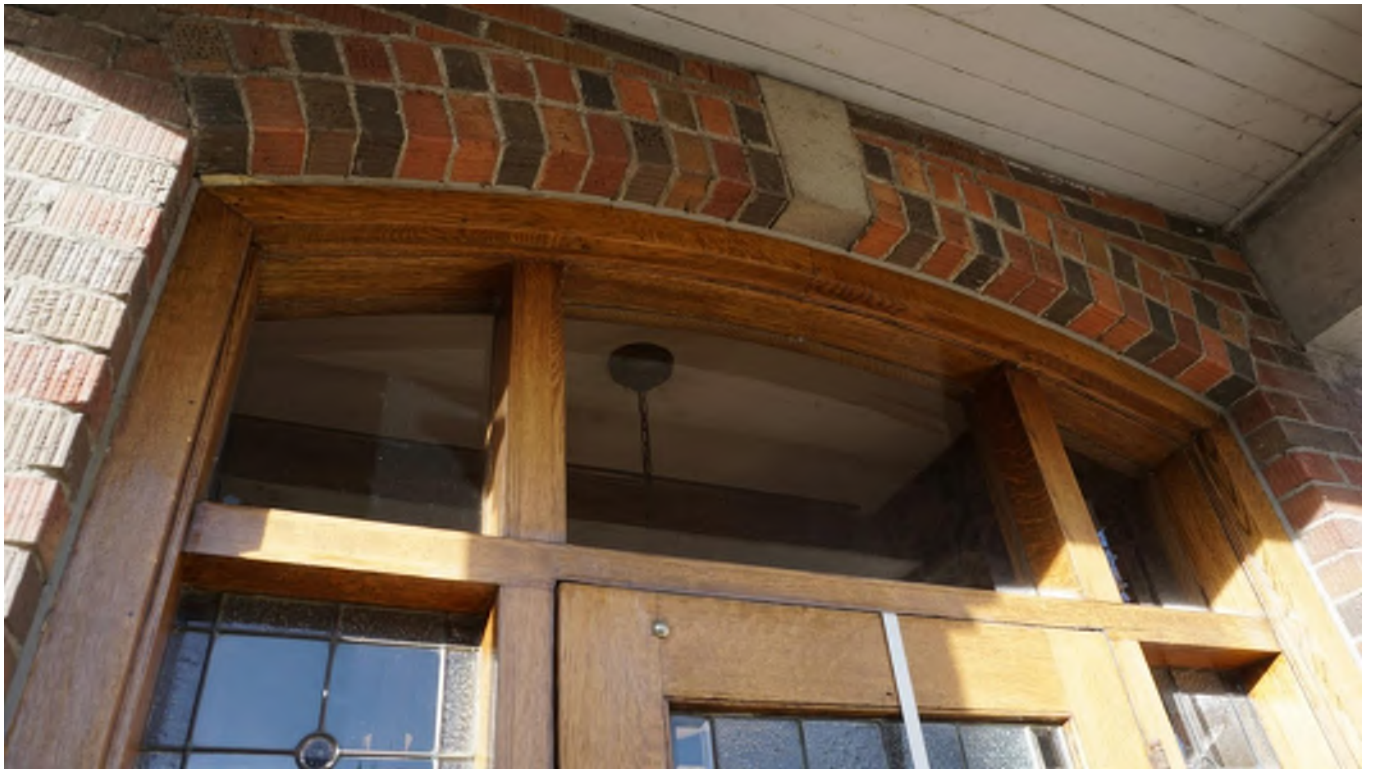
Figure 15 - Example of sealants around the front entrance.

| Sealants | | |
|---|---|---|
| Type of Reserve Allocation | <p>An allocation is made for the removal of old sealants, surface preparation, and application of new sealants on a portion of the building on an as needed basis.</p> | |

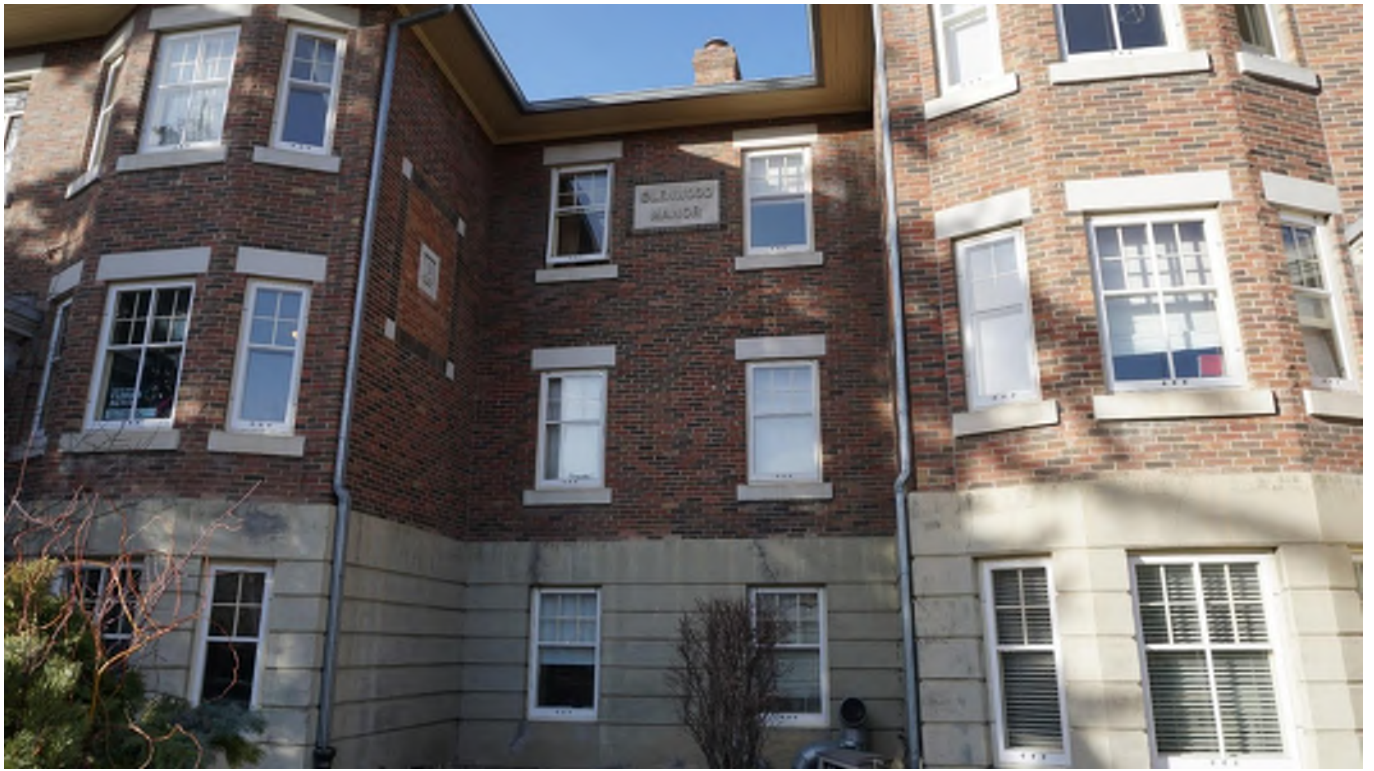
Figure 16 - Typical main building windows.

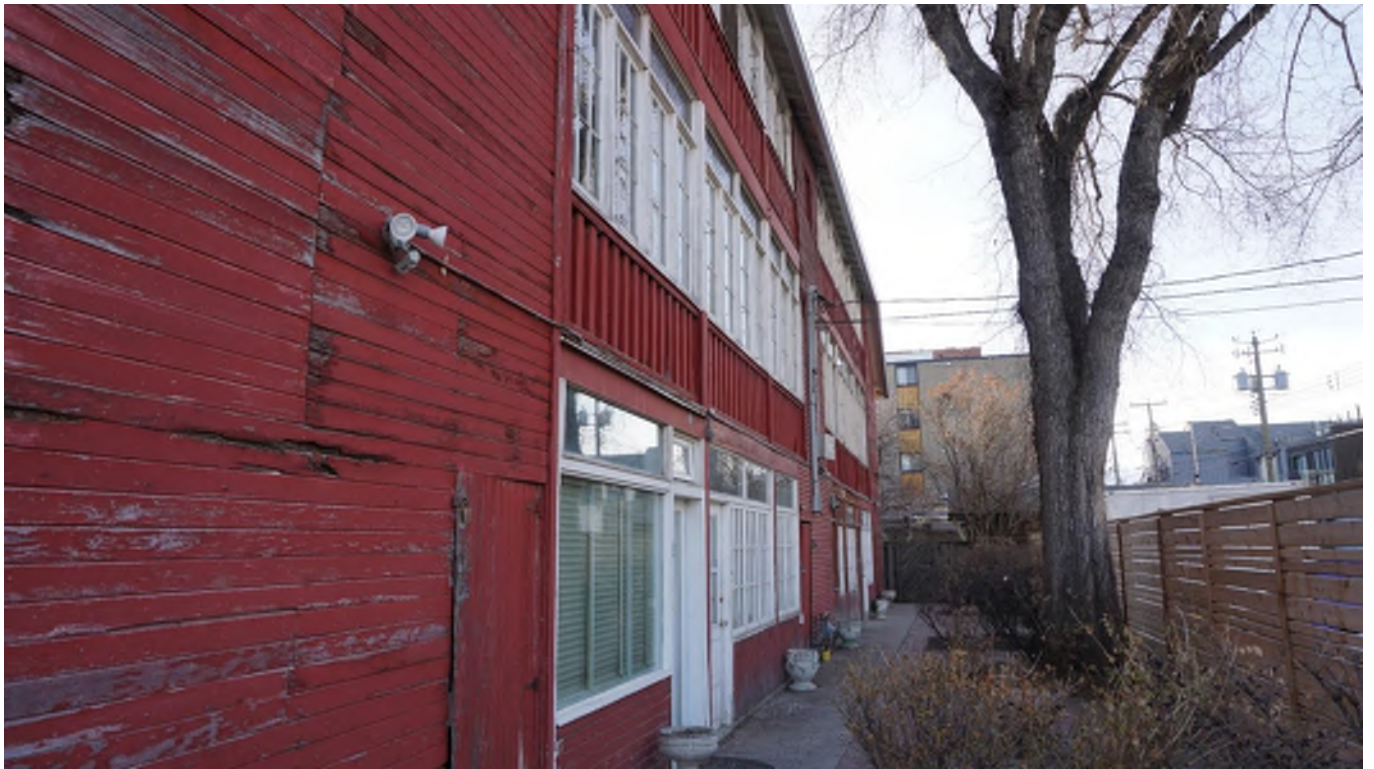
Figure 17 - Example of rear exterior windows on the veranda.

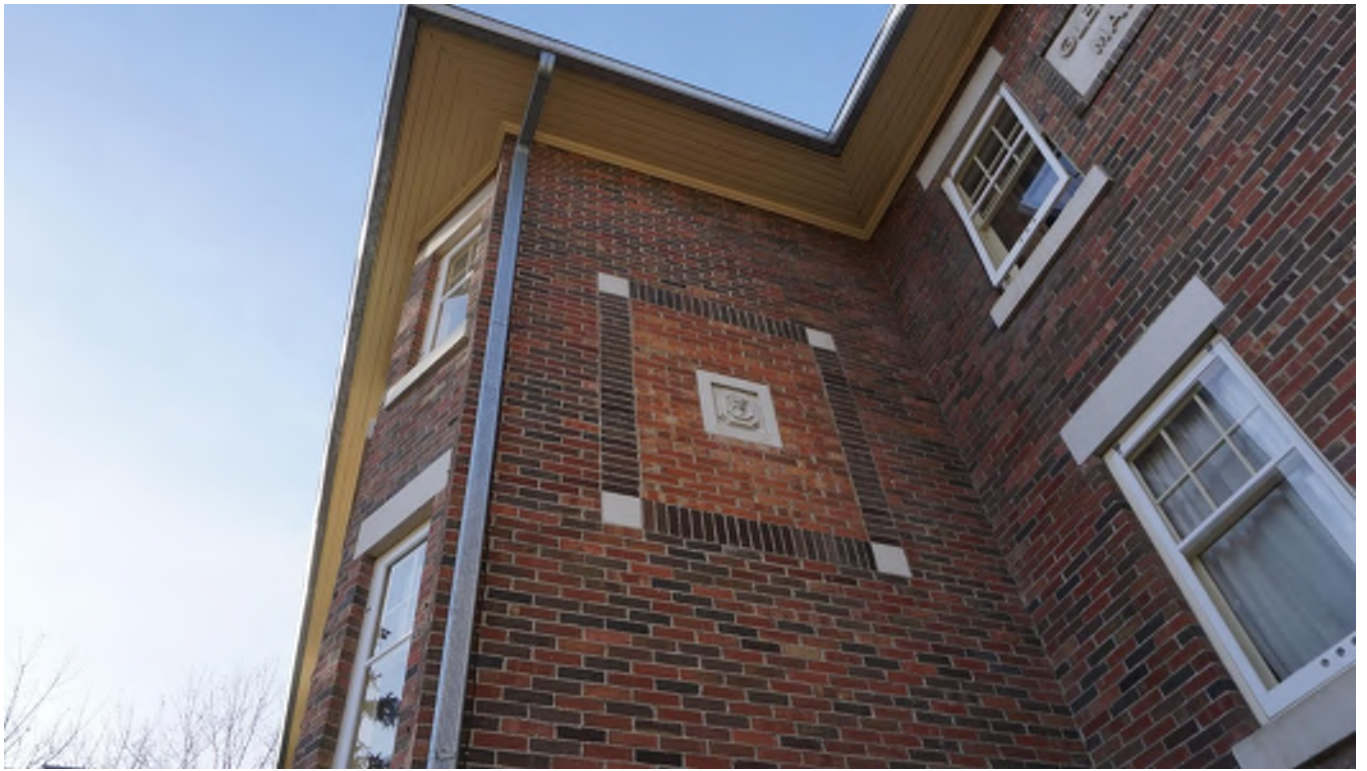
Figure 19 - Example of painted wood soffit boards.

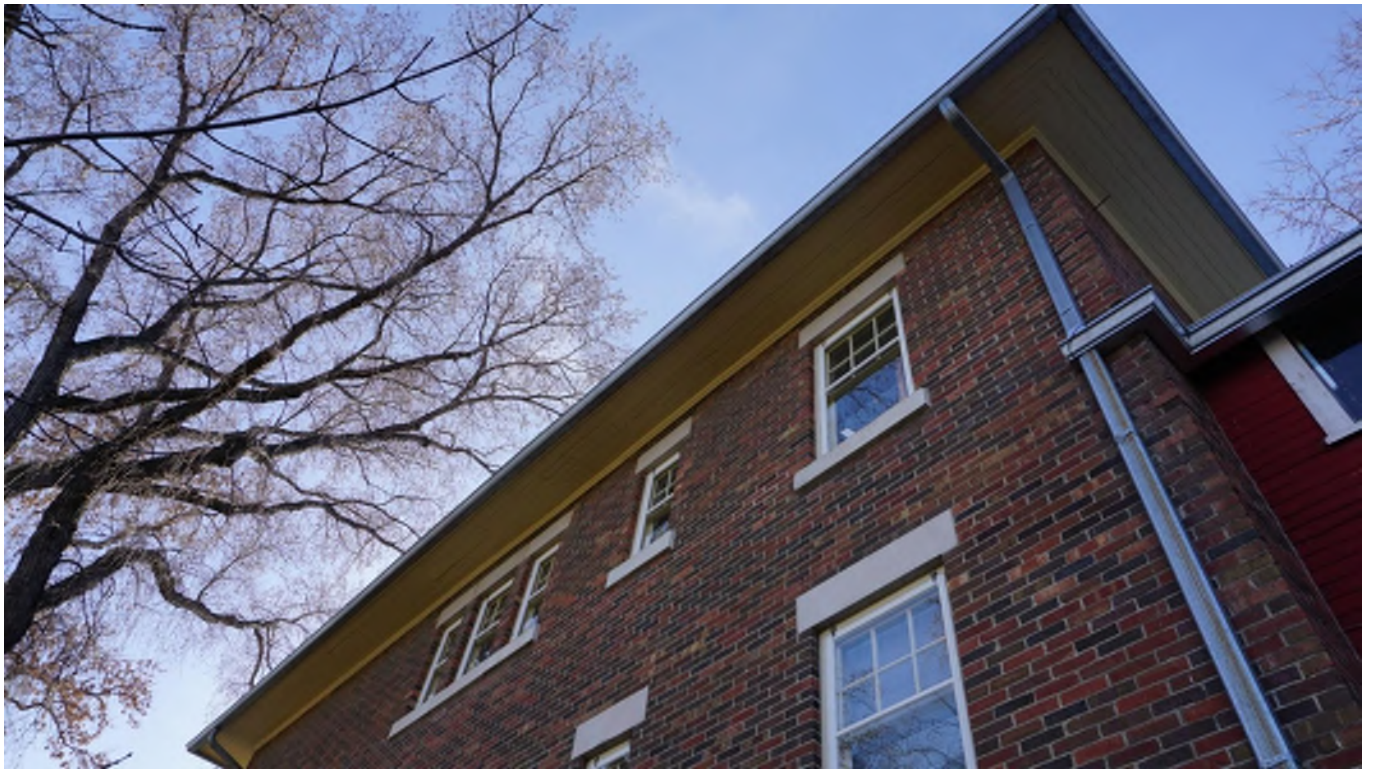
Figure 20 - View of galvanized gutters and downspouts.

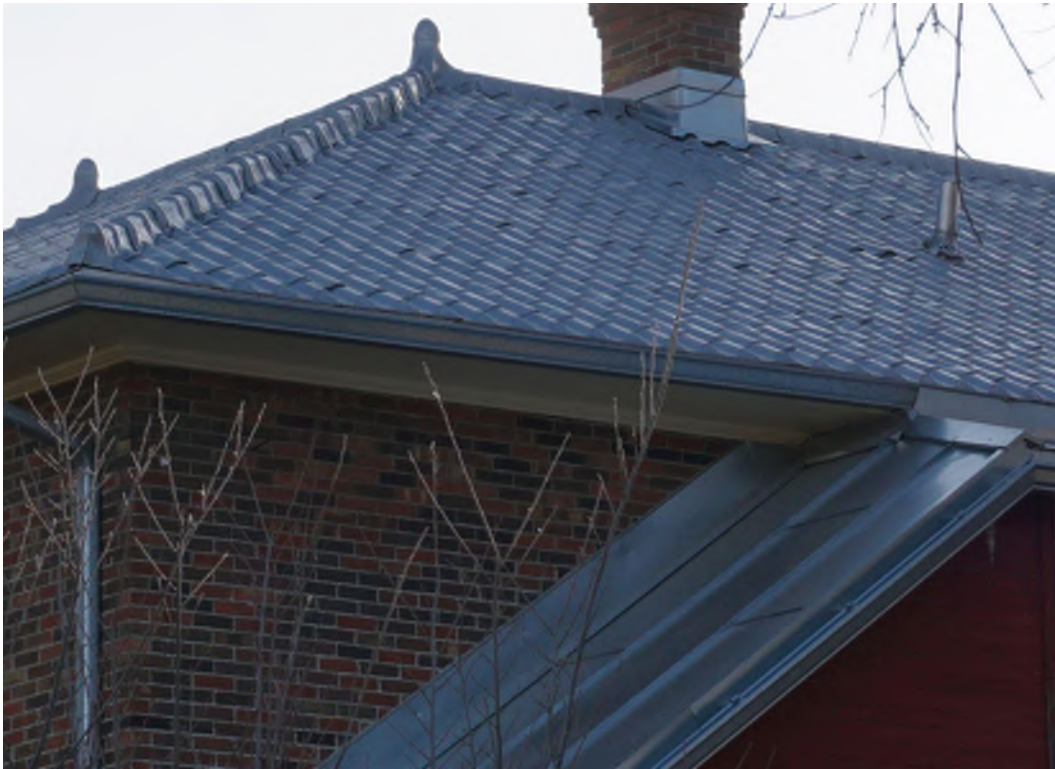
Figure 21 - View of Spanish Tile metal roof shingles.

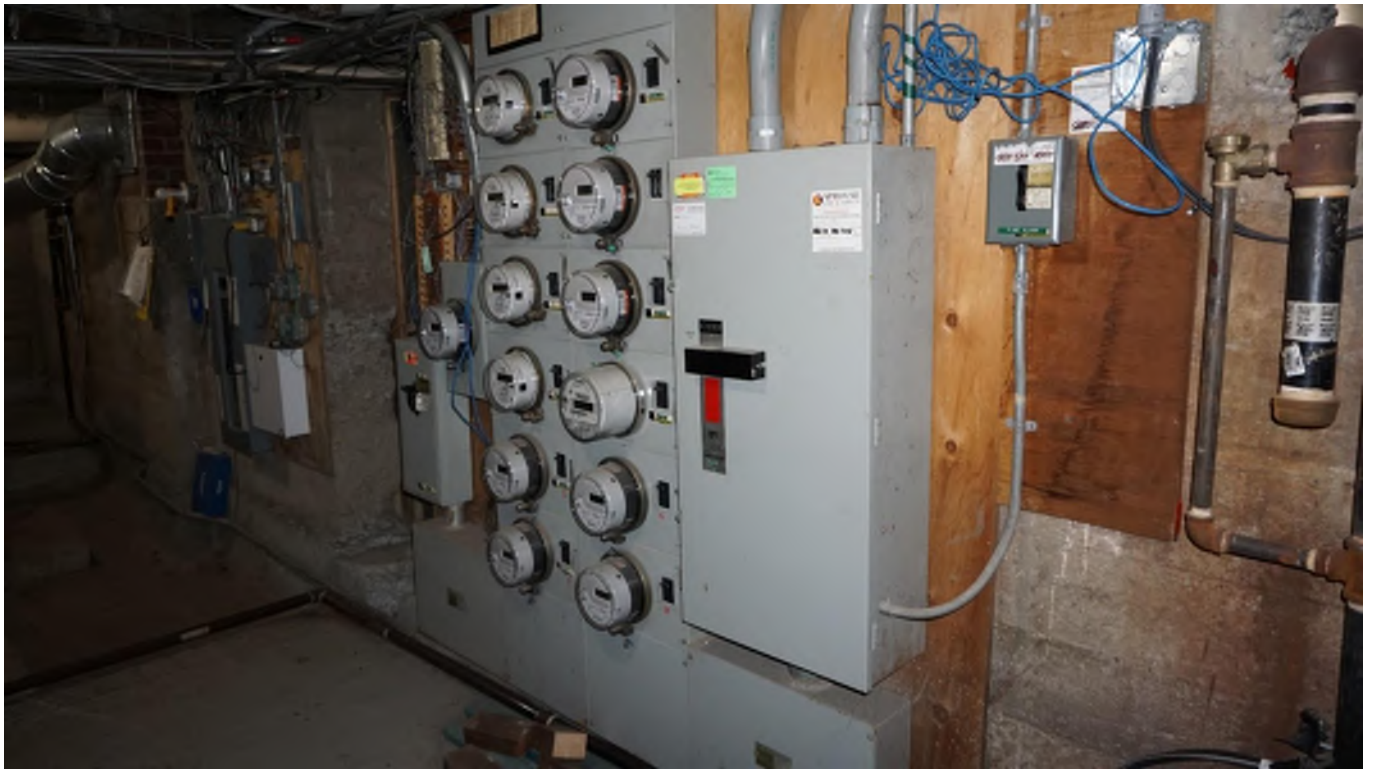
Figure 27 - Power distribution equipment in the basement.

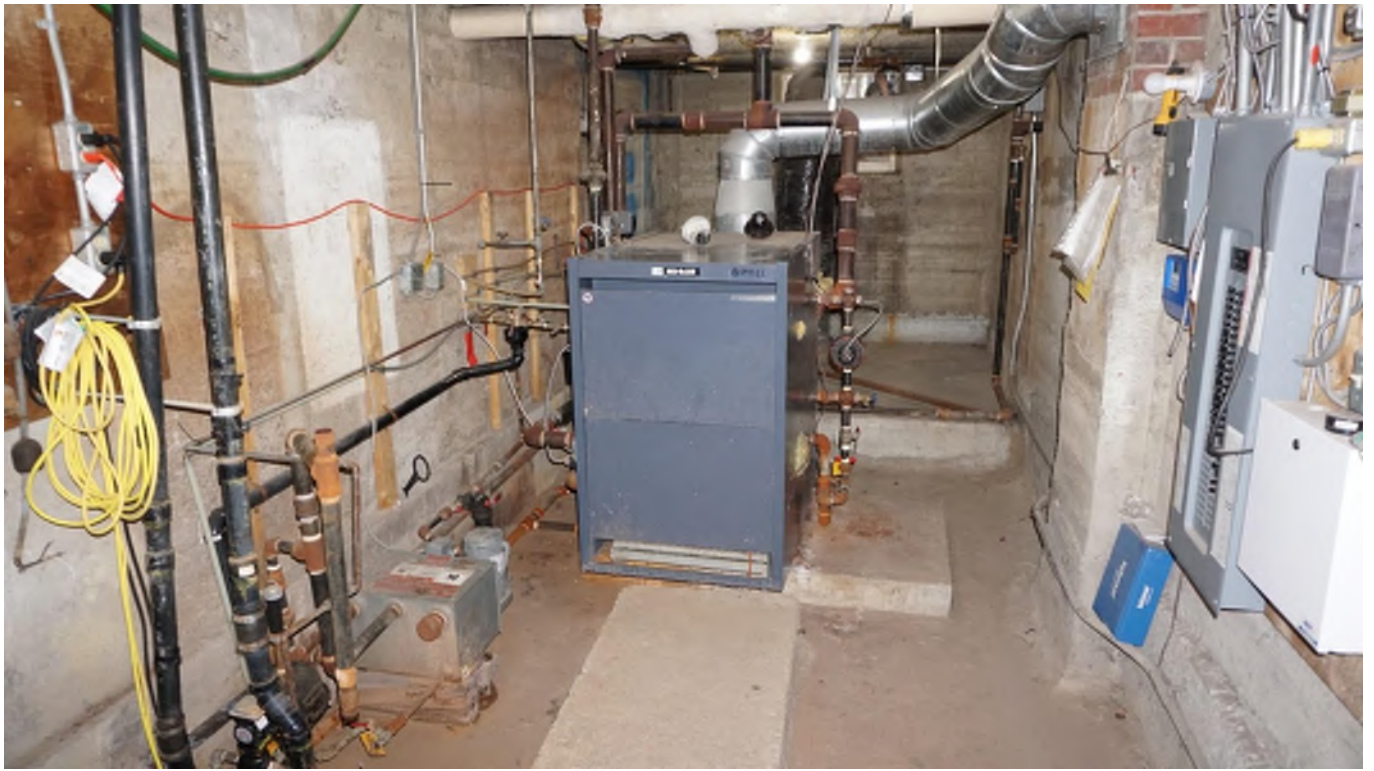
Figure 29 - Weil-McLain steam boiler.

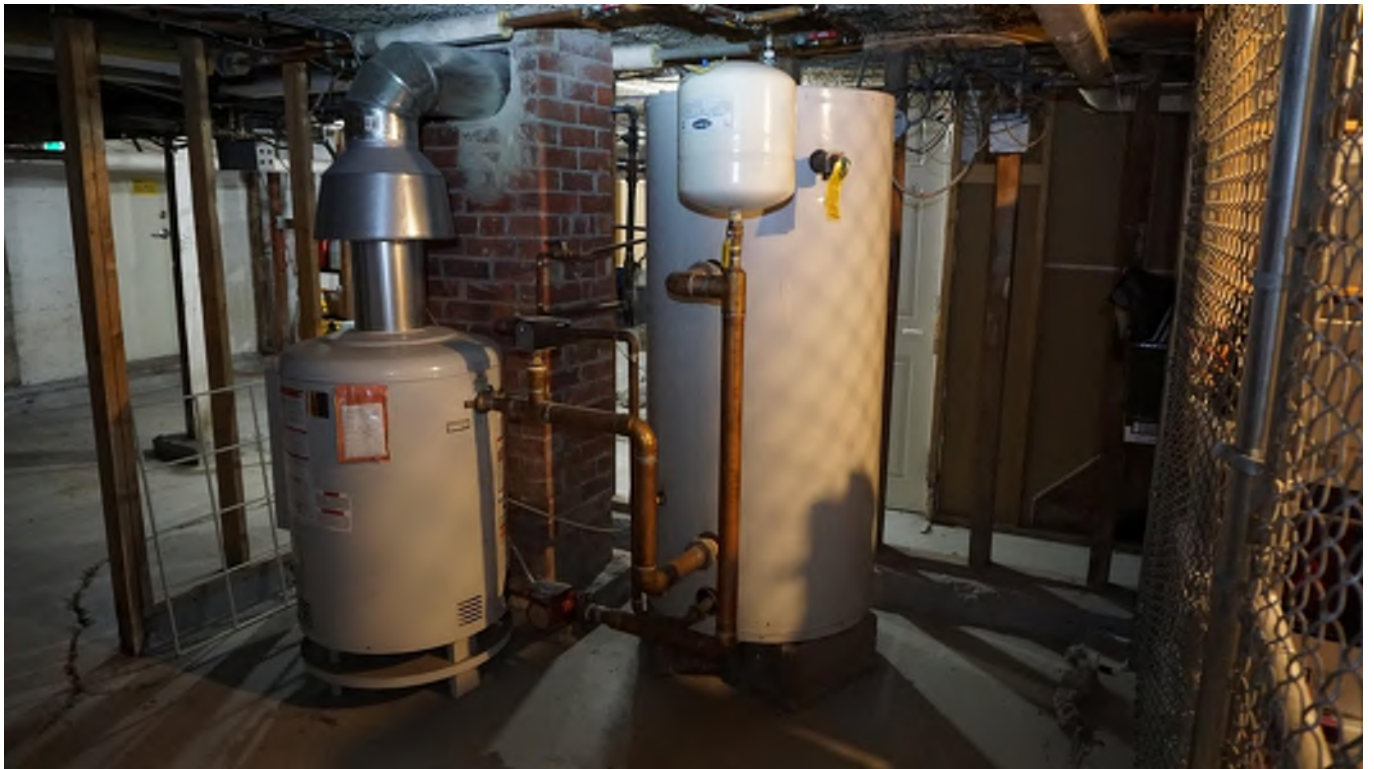
Figure 30 - AO Smith hot water supply boiler, storage tank and expansion tank.

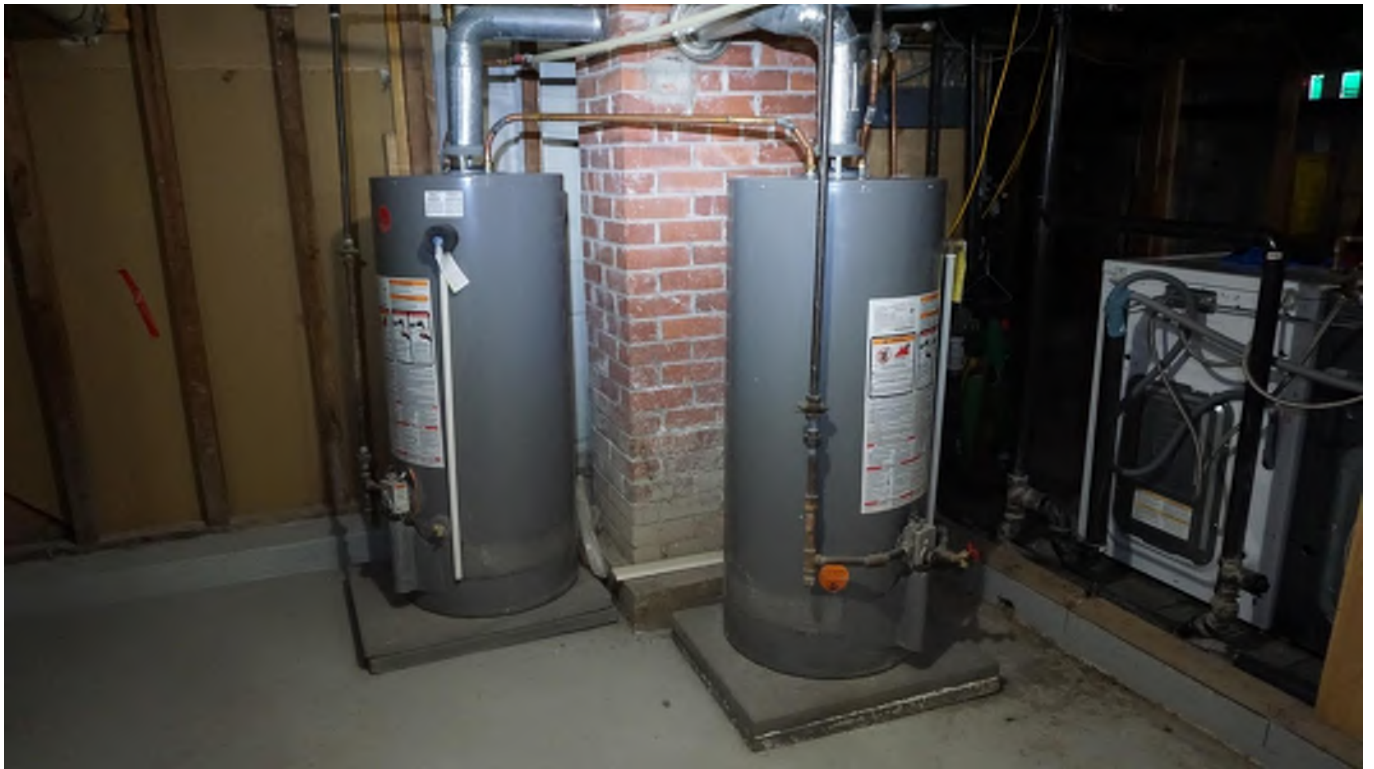
Figure 32 - Rheem domestic hot water heaters.

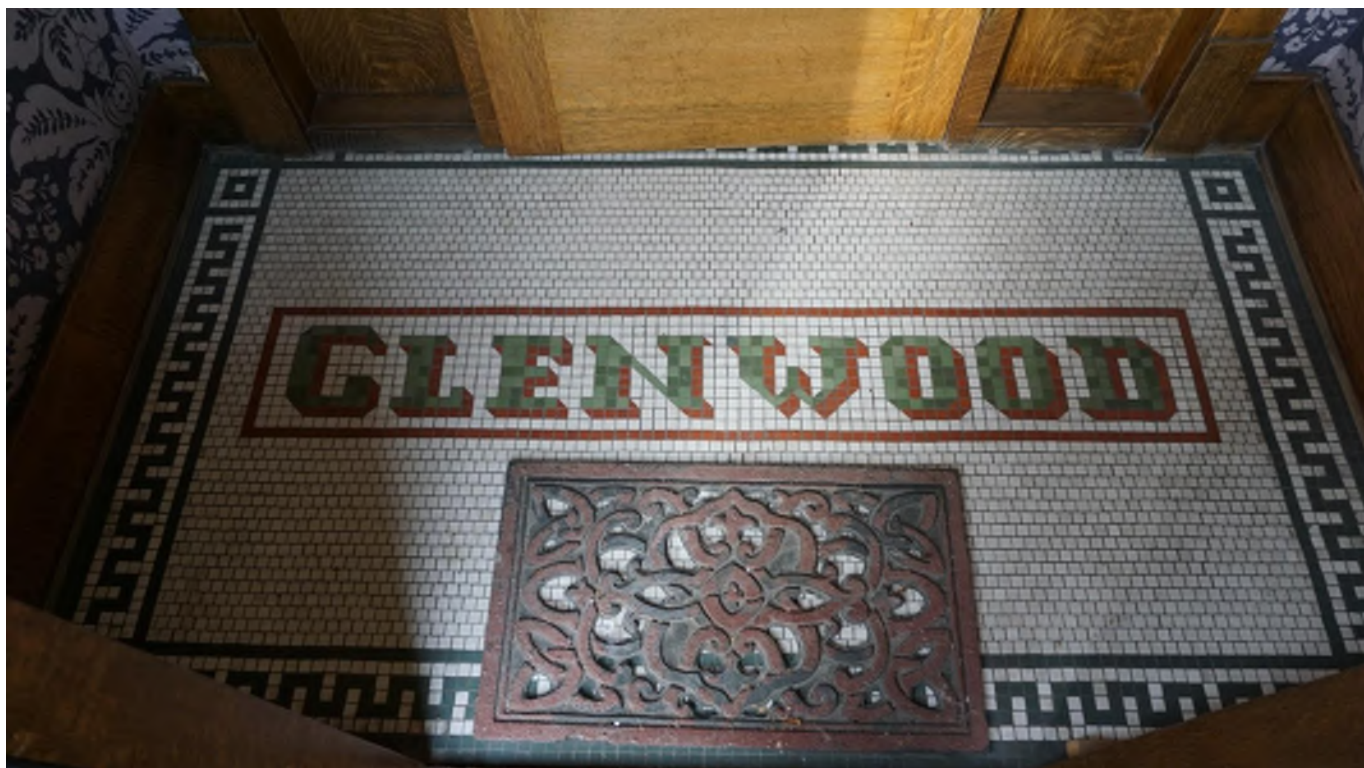
Figure 50 - Mosaic tile installation.

| Floor Tile - grout replacement/tile repair | | |
|---|---|---|
| Condition Analysis | The floor tile appeared to be in satisfactory condition. Only minor tile and grout damage was noted. | |

| Floor Tile - grout replacement/tile repair | | |
|---|---|---|
| Type of Reserve Allocation | An allocation has been made for the removal and replacement of the grout with a contingency for tile repair. | |

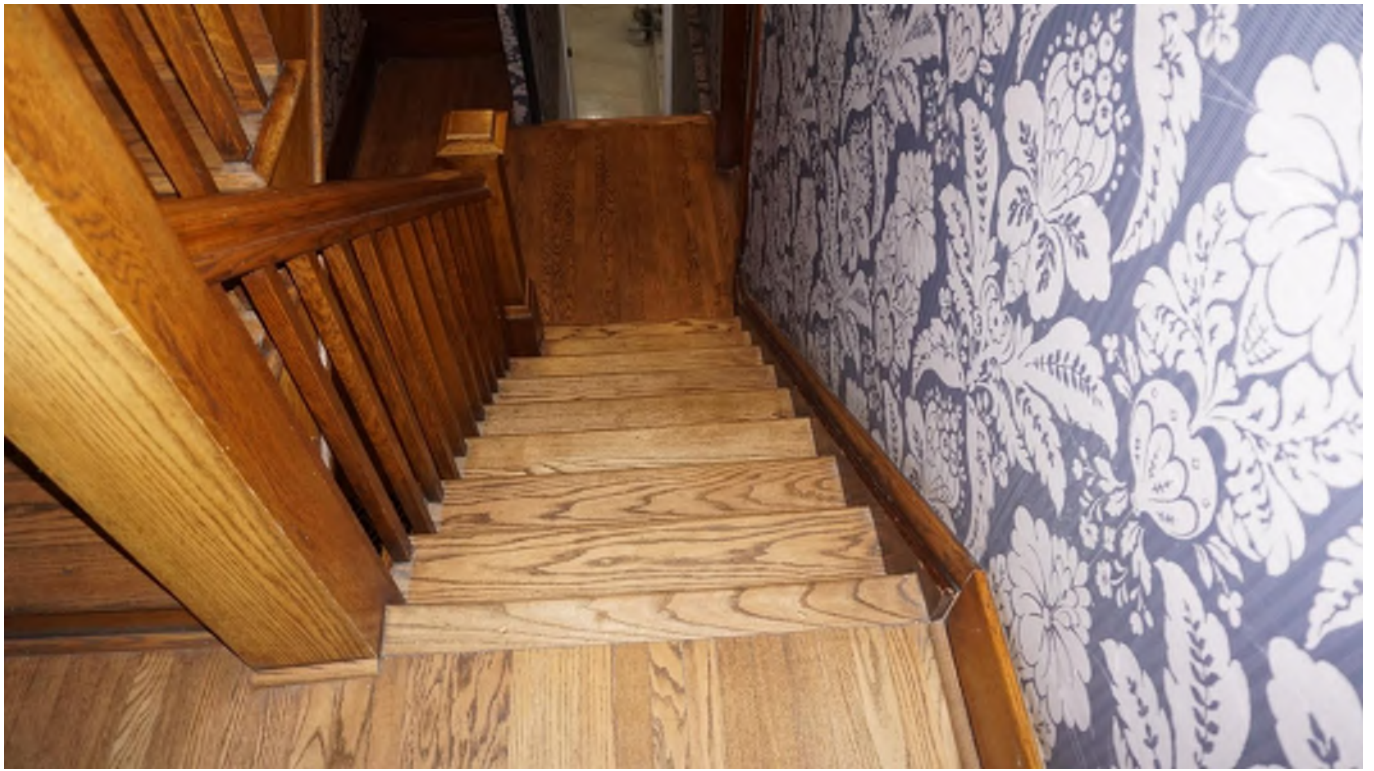
Figure 51 - View of the hardwood floor and stairs.

| Hardwood Floor - Refinishing | | |
|---|---|---|
| Condition Analysis | <p>The hardwood flooring appeared to be in satisfactory condition, with some scuffs &amp; scrapes noted. It is unknown how many re-finishings have been undertaken during the life of the floor.</p> <p>The manager advised that the board was considering an interior common area renovation in 2024/2025.</p> | |

| Hardwood Floor - Refinishing | | |
|---|---|---|
| Type of Reserve Allocation | <p>An allocation is made for the refinishing of the existing hardwood floor in both buildings, along with a contingency for repair.</p> | |

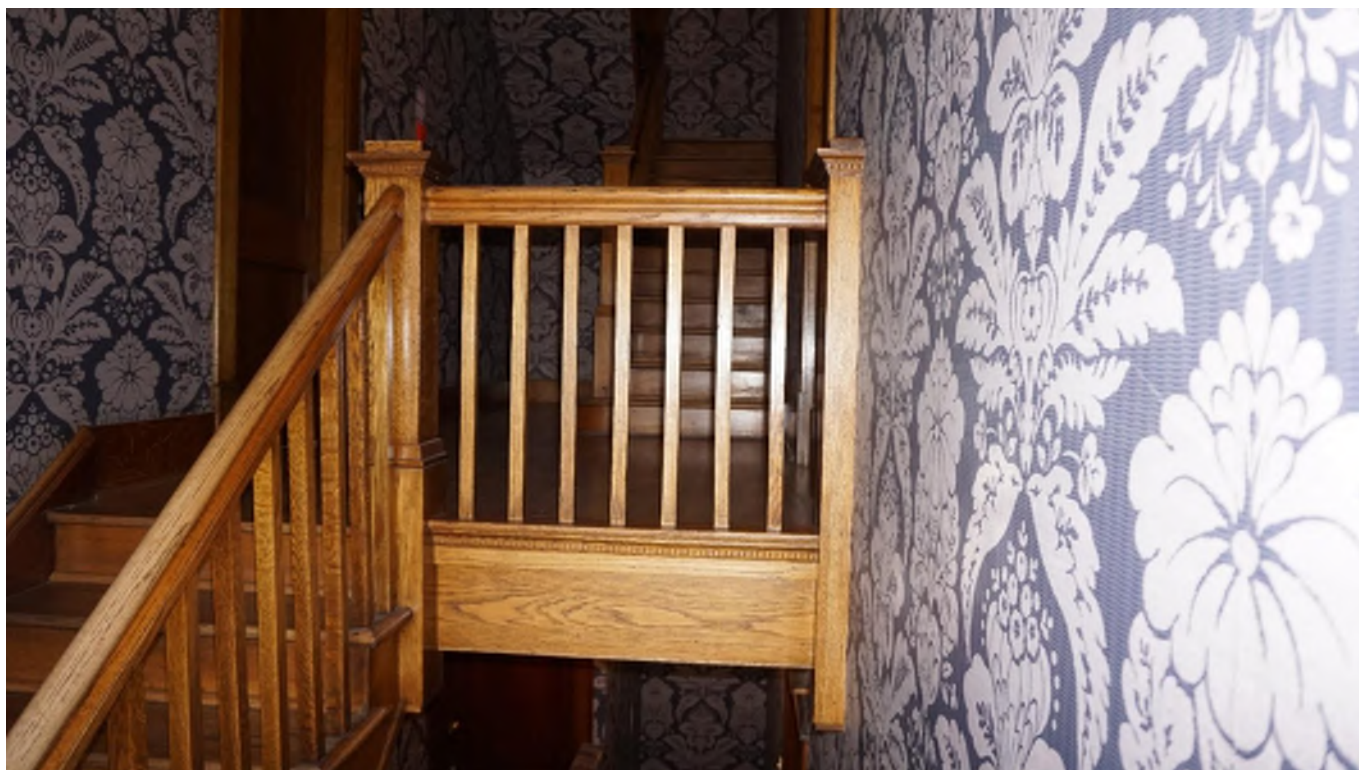
| Stairwell Rails, Posts, Balusters - Wood - Refinishing | | |
|---|---|---|
| Condition Analysis | The stairwell rails, posts, and balusters appeared to be in satisfactory condition, with some scuffs & scrapes noted. | |

Figure 52 - Stairwell posts and rails in Building 904.

Figure 53 - Stairwell posts and rails in Building 908.

| Stairwell Rails, Posts, Balusters - Wood - Refinishing | | |
|---|---|---|
| Type of Reserve Allocation | An allocation is made for the refinishing of the existing rails, posts, and balusters, along with a contingency for repair. | |

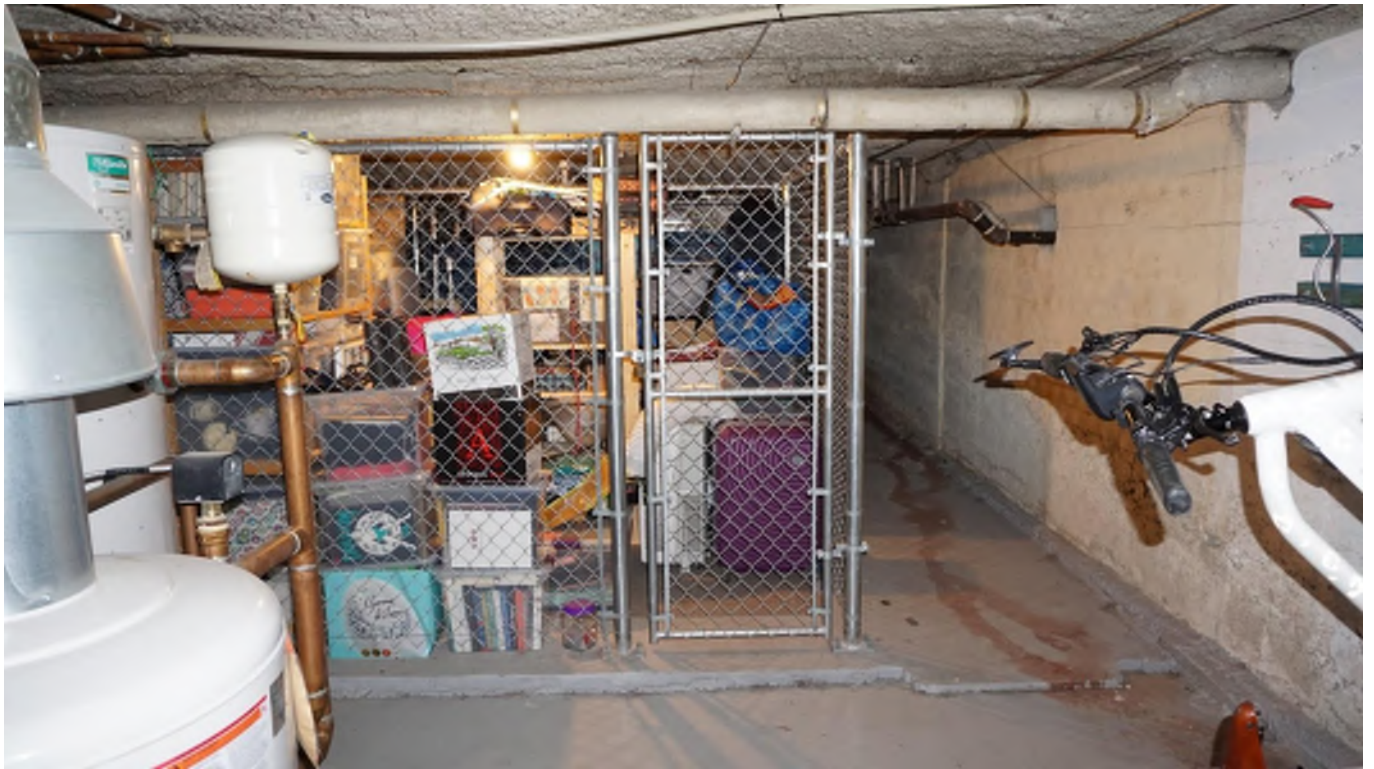
Figure 56 - Chain link storage lockers.

| Miscellaneous | | |
|---|---|---|
| Condition Analysis | The chain link lockers appeared to be in satisfactory condition. | |

| Miscellaneous | | |
|---|---|---|
| Type of Reserve Allocation | This component includes a contingency for repair or partial replacement of miscellaneous components every 15 years. | |
