Glenwood Manor - Condominium Corporation No. 8110119

April 15, 2024

**Re: Reserve Fund Study for Condominium Corporation No. 8110119 - 904 & 908 Memorial Drive NW**

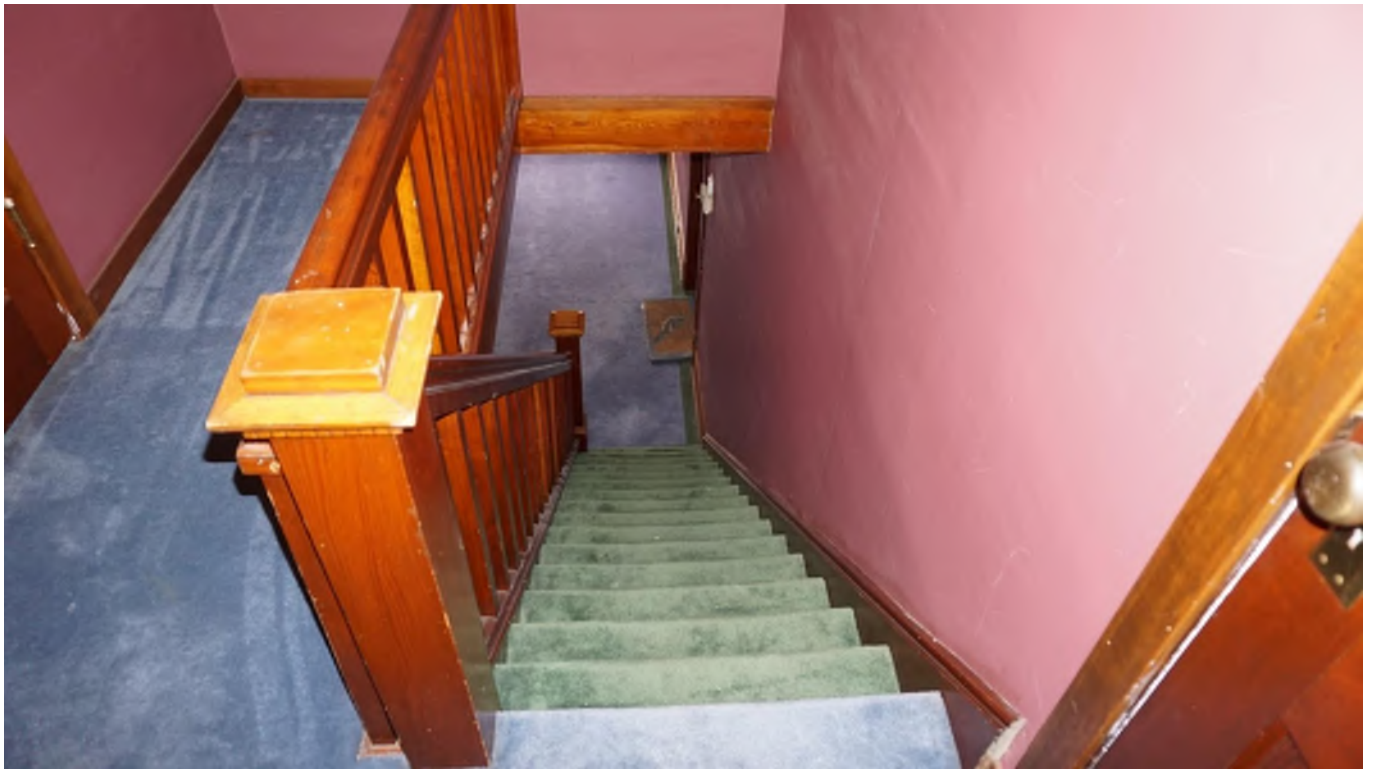
Figure 57 - Paint on the stairwell and landing to the attic floor in Building 908.

| Painting - 10 Year Cycle | | |
|---|---|---|
| Condition Analysis | <p>Damage was noted on the painted walls, including scuffs &amp; scratches, and some bubbling or peeling.</p> <p>The manager advised that the board was considering an interior common area renovation in 2024/2025.</p> | |

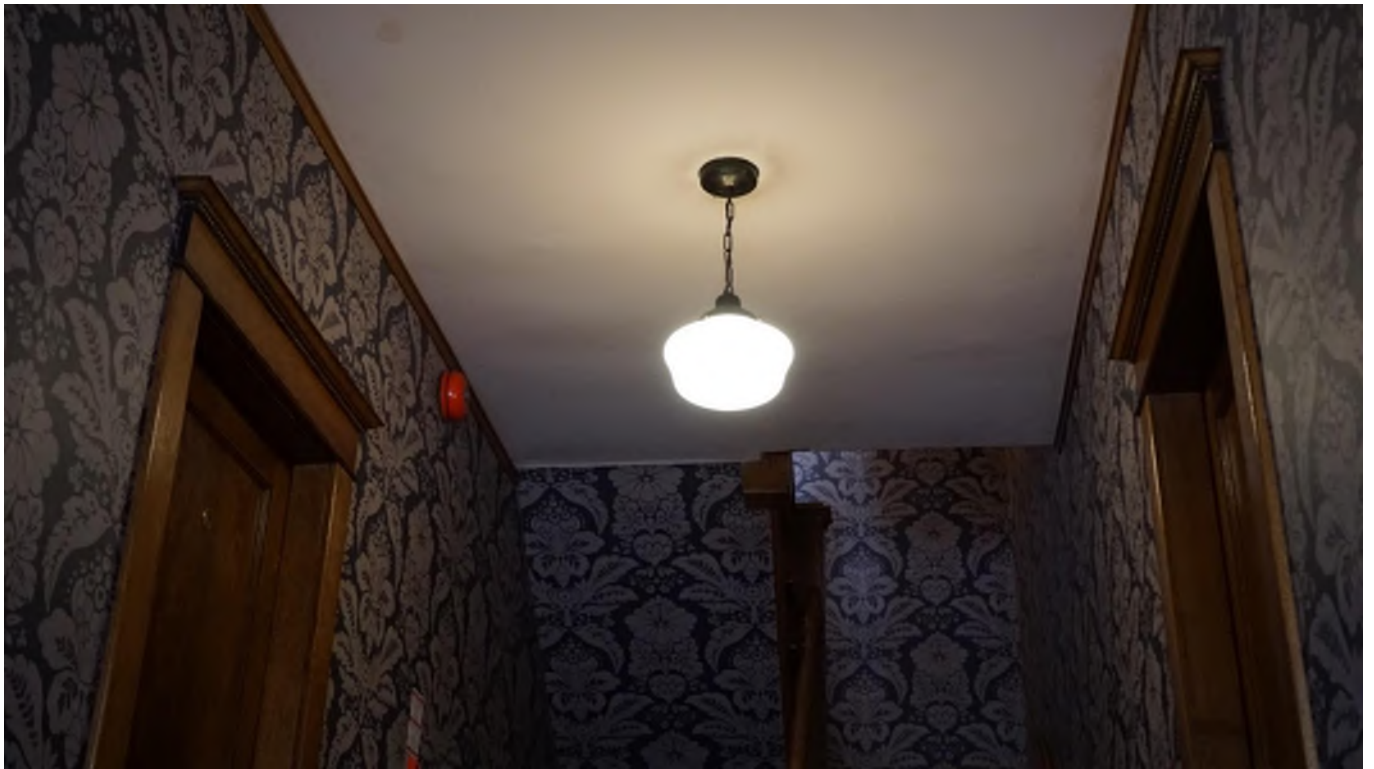
Figure 58 - 3rd floor ceiling.

| Painting - 20 Year Cycle | | |
|---|---|---|
| Condition Analysis | Overall, these components appeared to be in satisfactory condition. Some water staining and pollutant accumulation was noted. | |

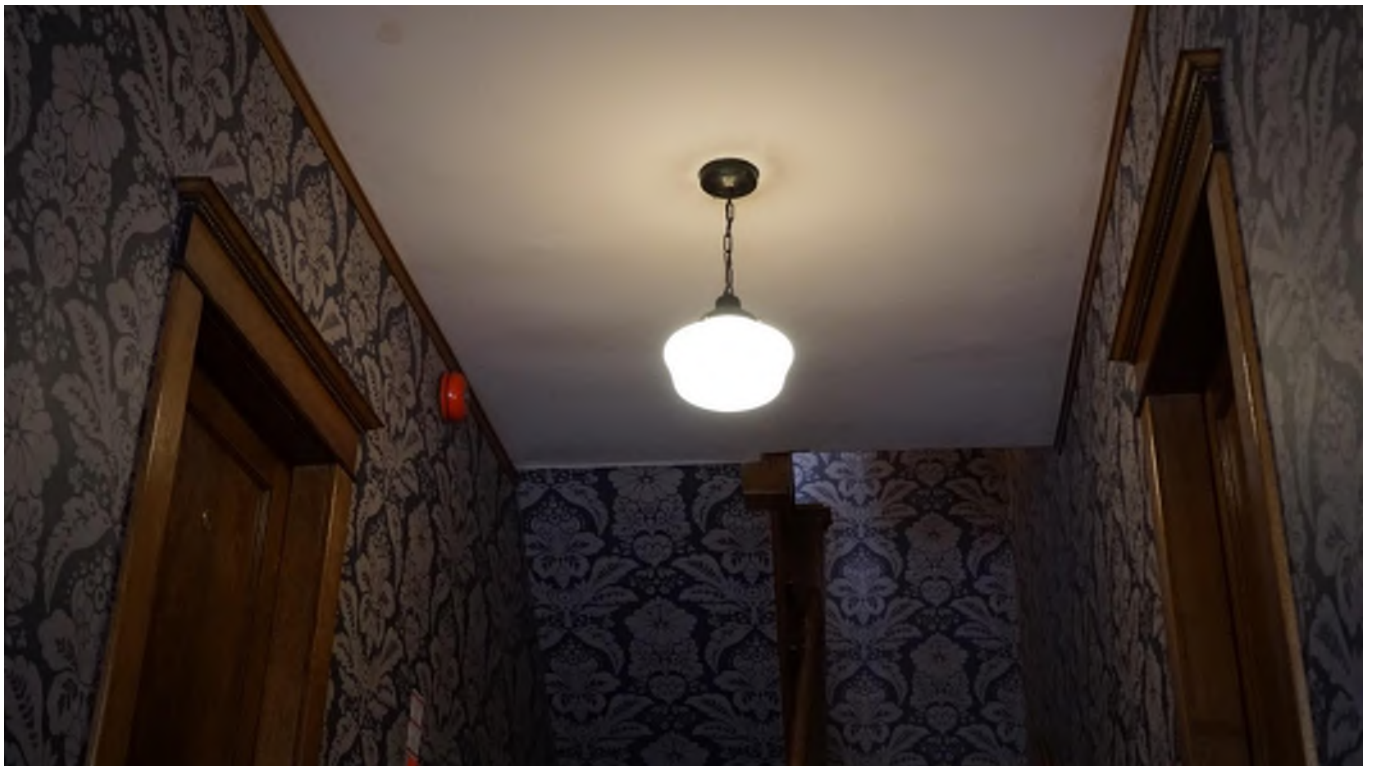
| Plaster | | |
|---|---|---|
| Condition Analysis | The plaster appeared to be in satisfactory condition. Damage associated with regular wear and tear in high traffic areas was noted as well as some minor water staining. | |

Figure 59 - Painted plaster walls on the attic floor.

Figure 60 - Painted plaster ceiling and wallpapered walls.

| Plaster | | |
|---|---|---|
| Type of Reserve Allocation | This component includes a contingency for repair or partial replacement of the wall and ceiling plaster in conjunction with the painting/wallpapering cycle. | |
