Glenwood Manor - Condominium Corporation No. 8110119

April 15, 2024

**Re: Reserve Fund Study for Condominium Corporation No. 8110119 - 904 & 908 Memorial Drive NW**

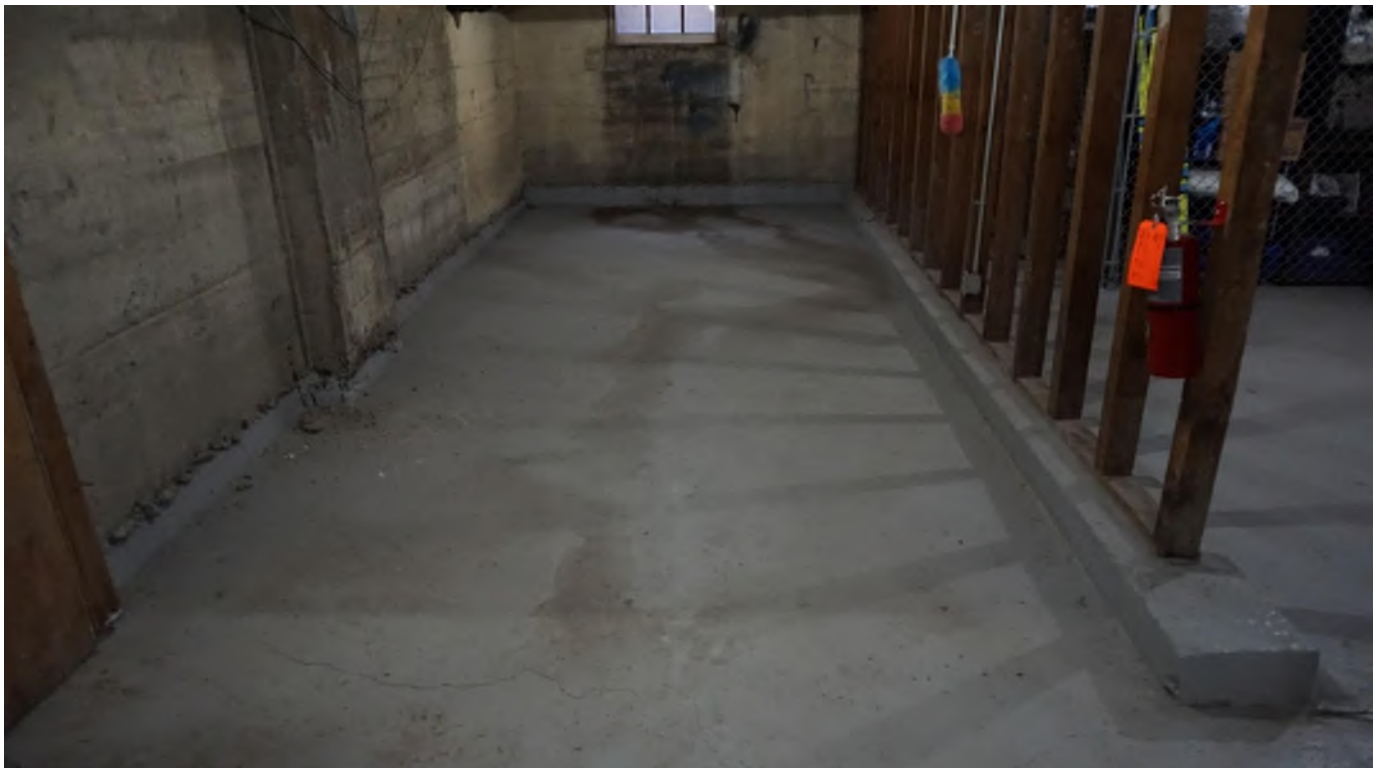
Figure 2 - Example of foundation walls, floors, columns, and footings.

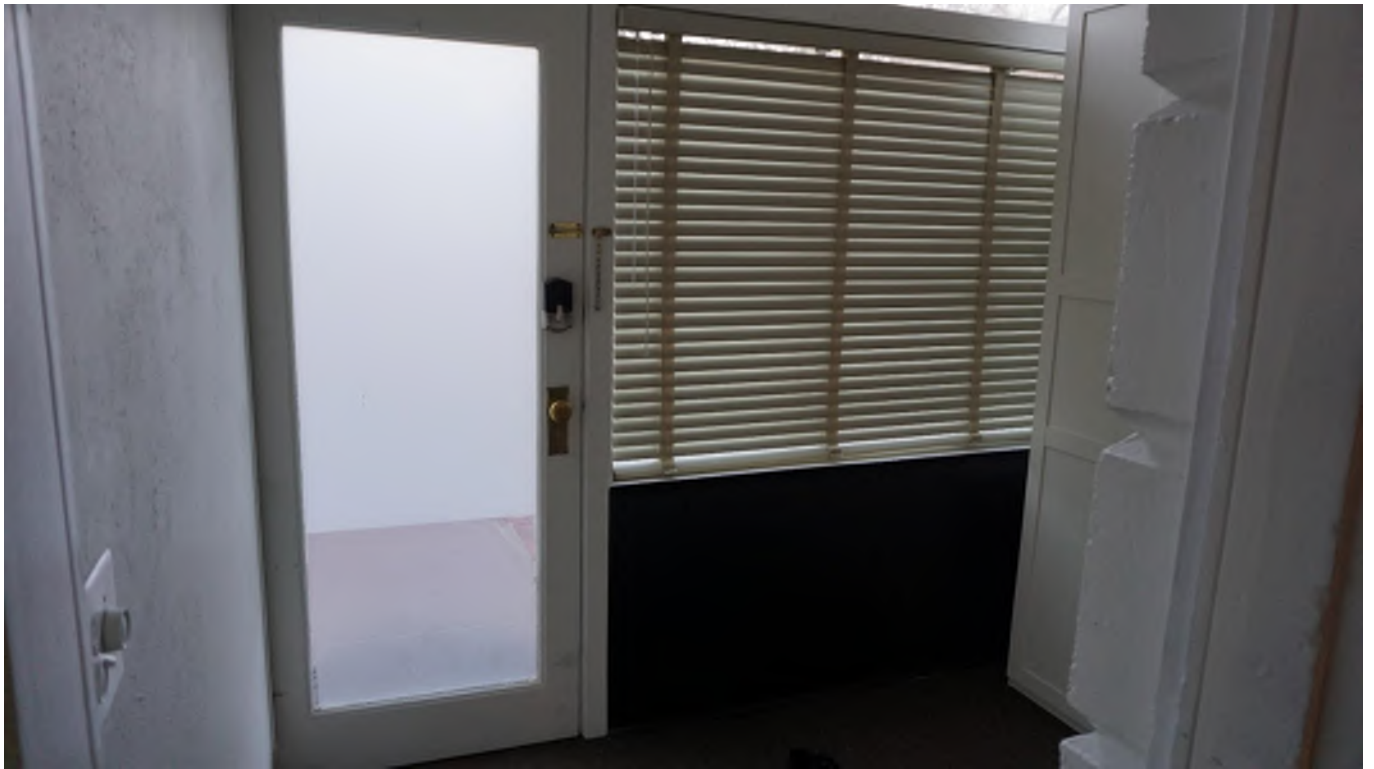
Figure 13 - Example of unit exit door at the rear of the building.

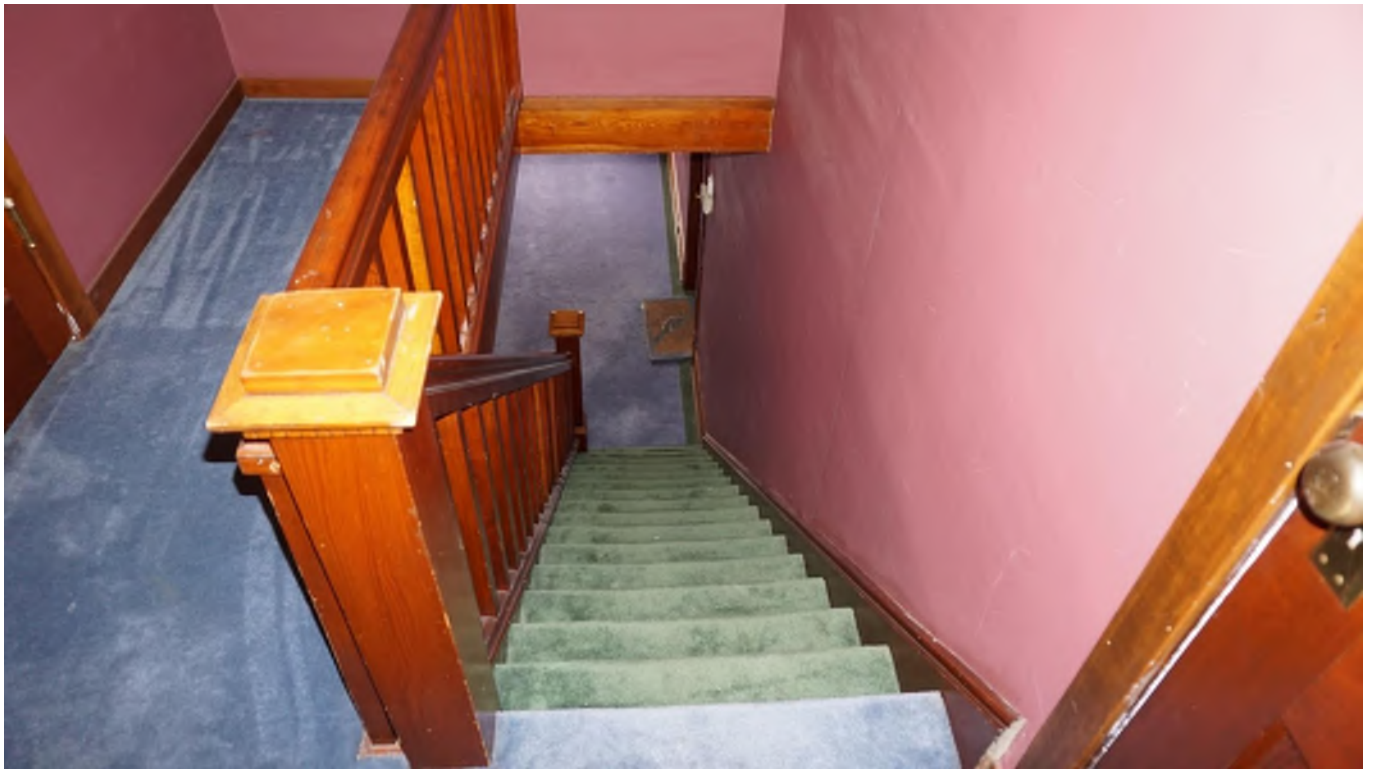
Figure 47 - Carpet in Building 908.

| Carpet | | |
|---|---|---|
| Condition Analysis | <p>The carpet in the attic office appears to be in satisfactory condition and the carpet in Building 908 common areas is reaching end-of-life.</p> <p>The manager advised that the board was considering an interior common area renovation in 2024/2025.</p> | |

| Carpet | | |
|---|---|---|
| Type of Reserve Allocation | <p>An allocation is made for the removal and replacement of the carpeting in the attic office at the end of the estimated service life, the removal of the carpet in Building 908 common areas and the installation of stairwell carpet runners in both buildings.</p> <p>No provision has been made for replacement of the existing carpet in the attic.</p> | |

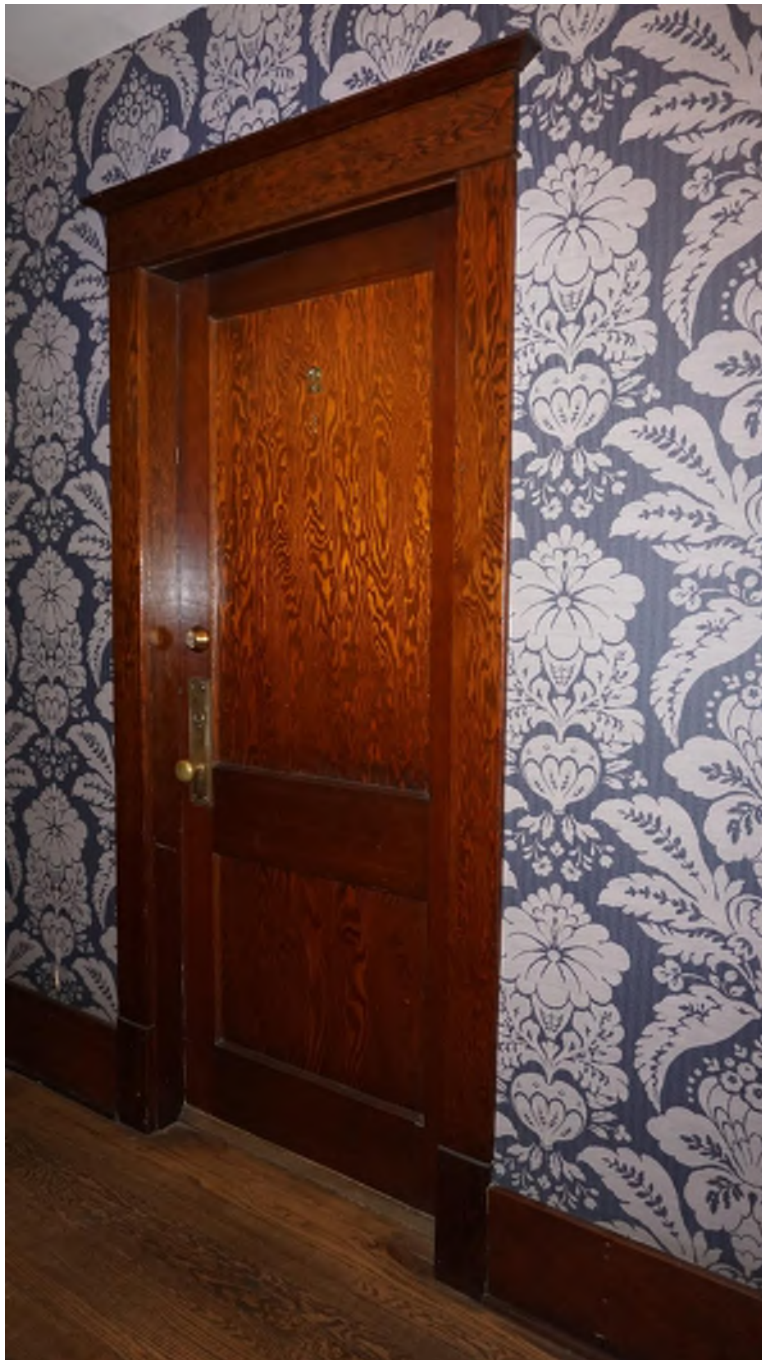
Figure 48 - Unit door.

| Doors | | |
|---|---|---|
| Condition Analysis | The doors, frames, and hardware appeared to be in satisfactory condition. Scratches and scuffs associated with regular wear and tear were noted. | |

| Doors | | |
|---|---|---|
| Type of Reserve Allocation | This component includes a contingency for repair or partial replacement of the doors, frames, and hardware and refinishing of the varnished wood doors and frames every 15 years. | |

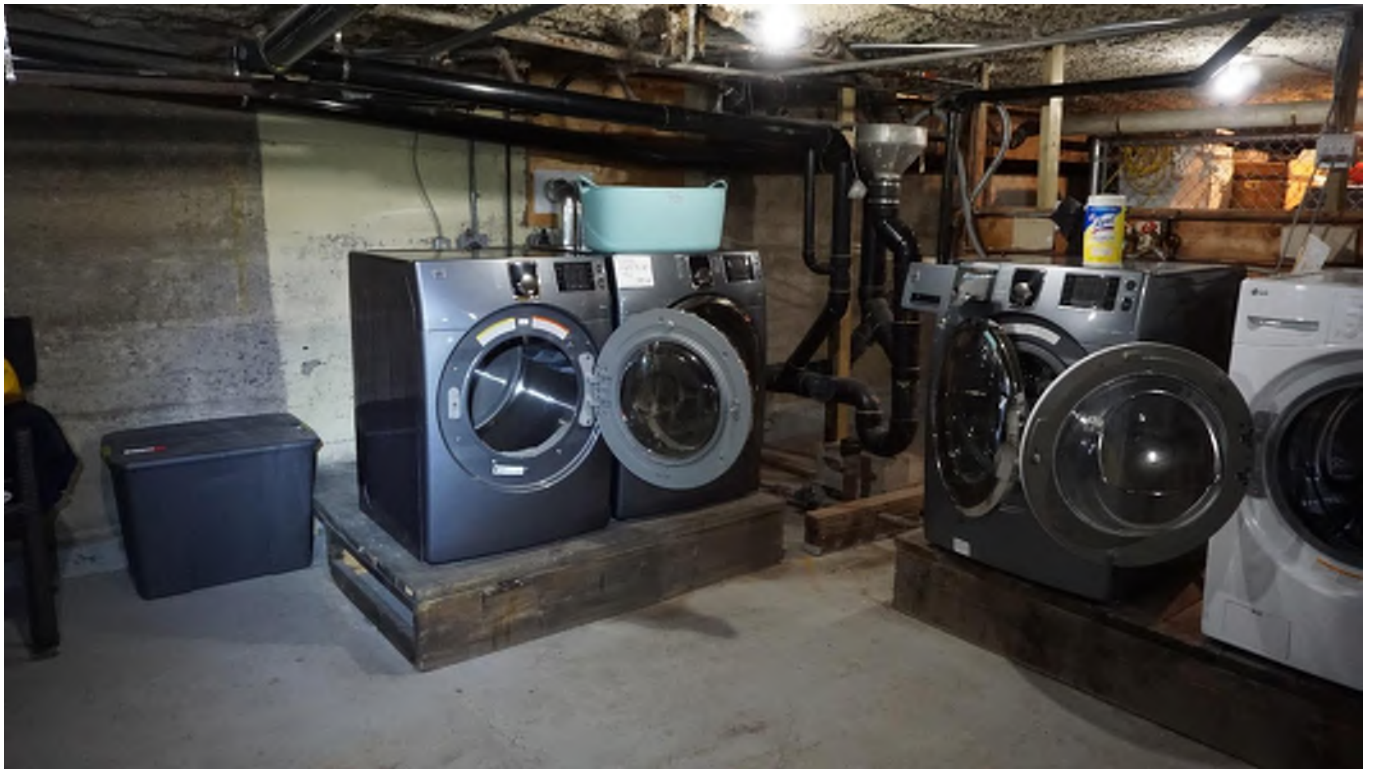
Figure 54 - Washer & dryer sets.

| Laundry Equipment | | |
|---|---|---|
| Condition Analysis | The appliances appeared to be in satisfactory condition. Management advised that two of the washer/dryer sets are from 2013 and two were just recently replaced in 2023. | |

| Laundry Equipment | | |
|---|---|---|
| Type of Reserve Allocation | This component includes a phased replacement of equipment such that two washing machines and two dryers are replaced every 8 years. It also includes the repair/replacement of the ducting and vent screens. | |

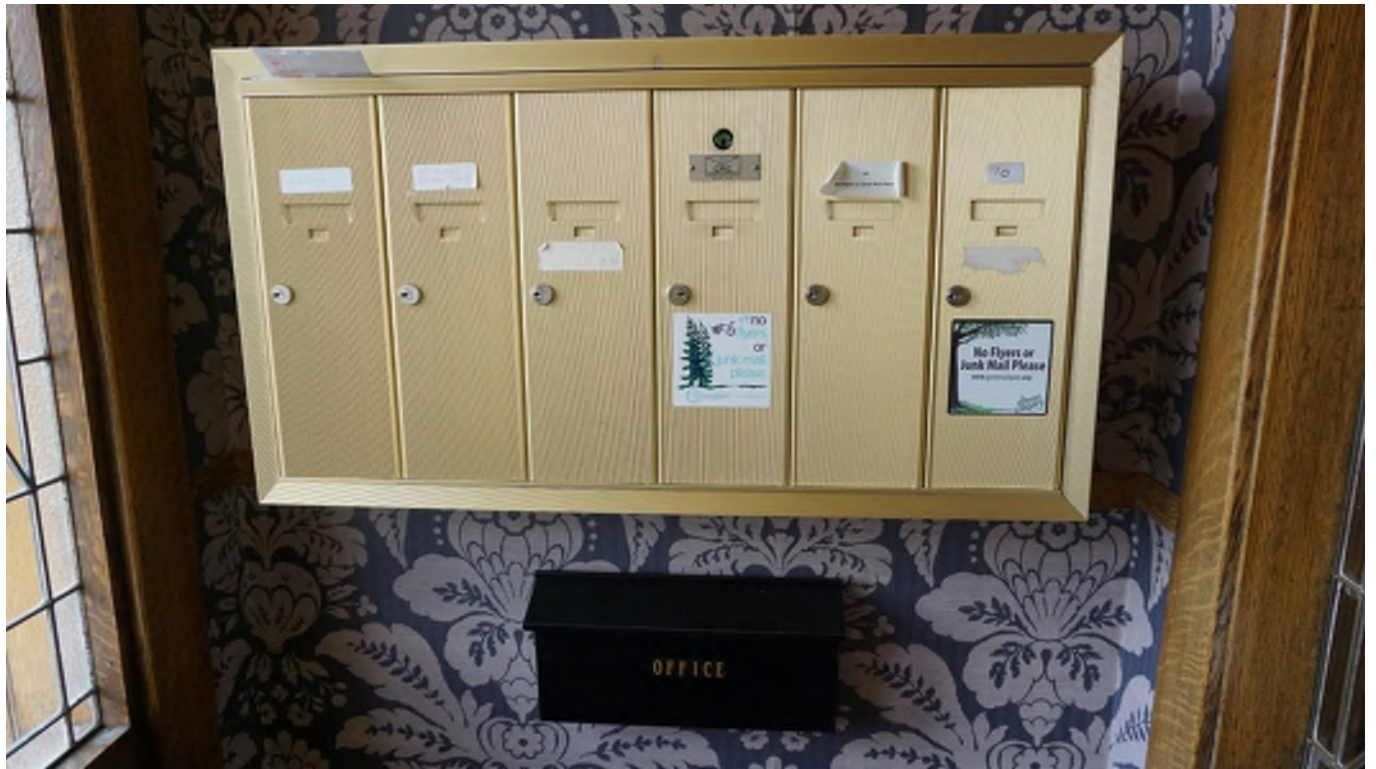
Figure 55 - Front load mailbox.

| Mailbox | | |
|---|---|---|
| Condition Analysis | The mailboxes appeared to be in good condition with no issues reported by management. Some minor scratching around the lock and glue debris was noted. | |

| Mailbox | | |
|---|---|---|
| Type of Reserve Allocation | An allocation is made for the complete replacement of the mailboxes at the end of the estimated service life. | |
